TAC UPDATE.

What Really Happened to Building 7?
First Clues Emerging

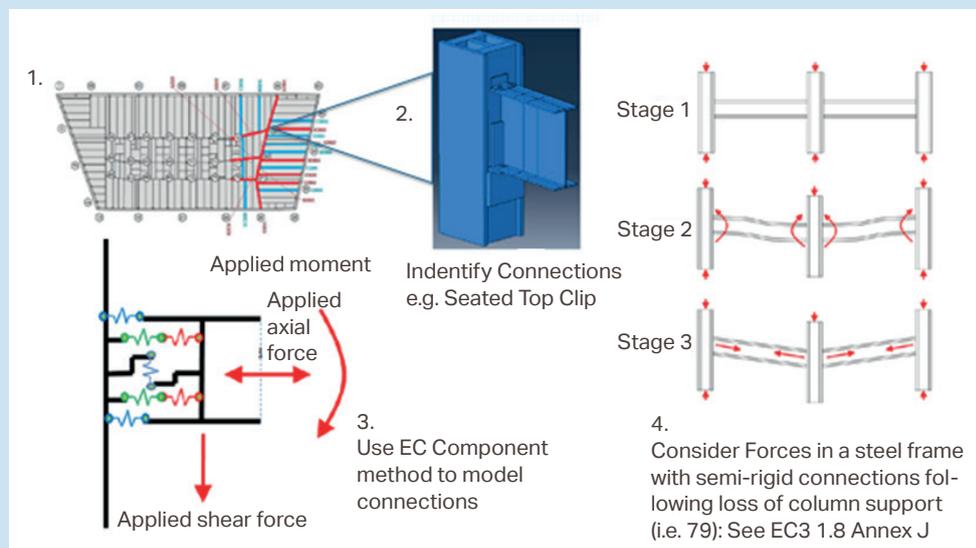
Figure 1. Wp1: East Penthouse Collapse Connections Analysis

1. Typical frame and column diagram for each floor.
2. Example connection at Column 79.
3. Component model for typical Connection.
4. Column collapse model showing resultant forces.vv

The UAF study had concluded that column 79 would not fail but descend only 10 feet, however we found that the building's structure only provided 75% of the resistance necessary, and therefore the column would continue to fall. Although the outcomes from both studies are different, both demonstrate that there is significant structural resistance in the building.

The analysis also indicated that if Column 79 collapsed, escalation to core Columns 80 and 81 could occur, but at the same time there would be substantial inward (catenary) forces imposed on the exterior frame.

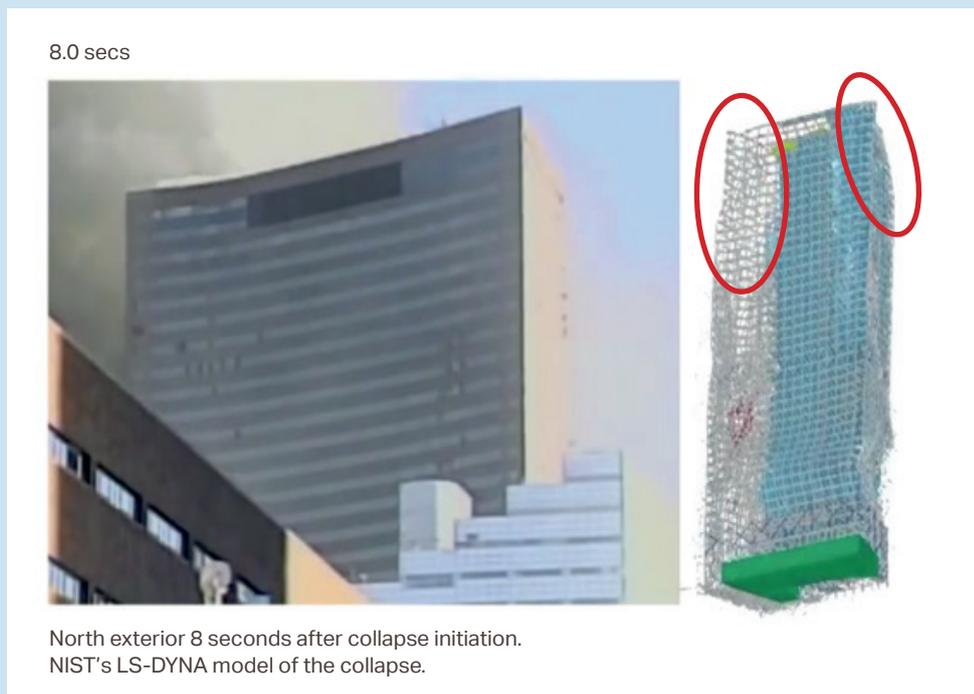
Figure 2. Video vs. NIST WTC7 collapse animation comparison

It is noteworthy that according to NIST's own dynamic analysis, a frame of which is shown alongside the video, the distortion of the exterior they predict (see the red circles) is not seen in reality. Such significant differences observed between reality and modelling suggest to the TAC, a different collapse mechanism may be applicable.
