Wind turbine gearbox bearing failures

White structure flaking: causes 60-85% of gearbox bearing failures

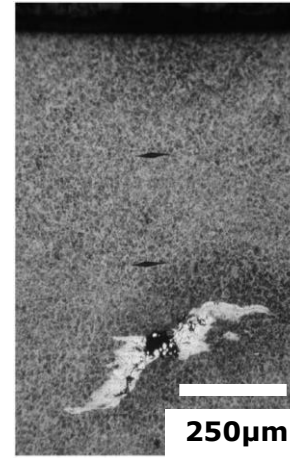
Butterfly

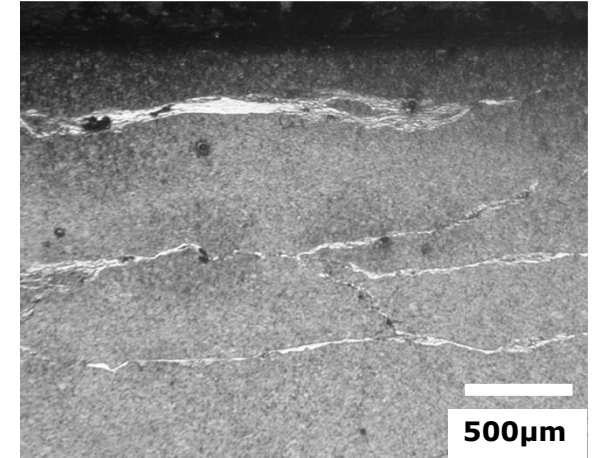
White etching crack network

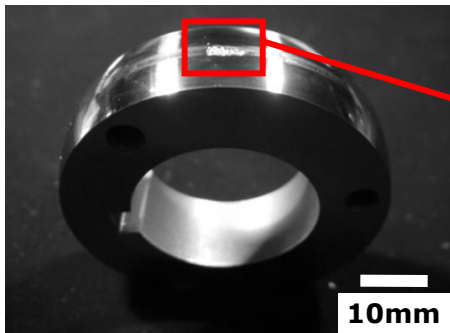
Lab test rollers showing spalling failure

Spall on wear track

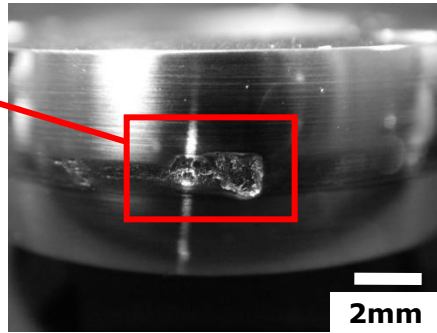
Zoom of spall
