RAIB investigations: the risks that we see

Carolyn Griffiths
Chief Inspector
Rail Accident Investigation Branch

Passenger train derailment at East Langton 20 February 2010

Camden Road Oct 2013

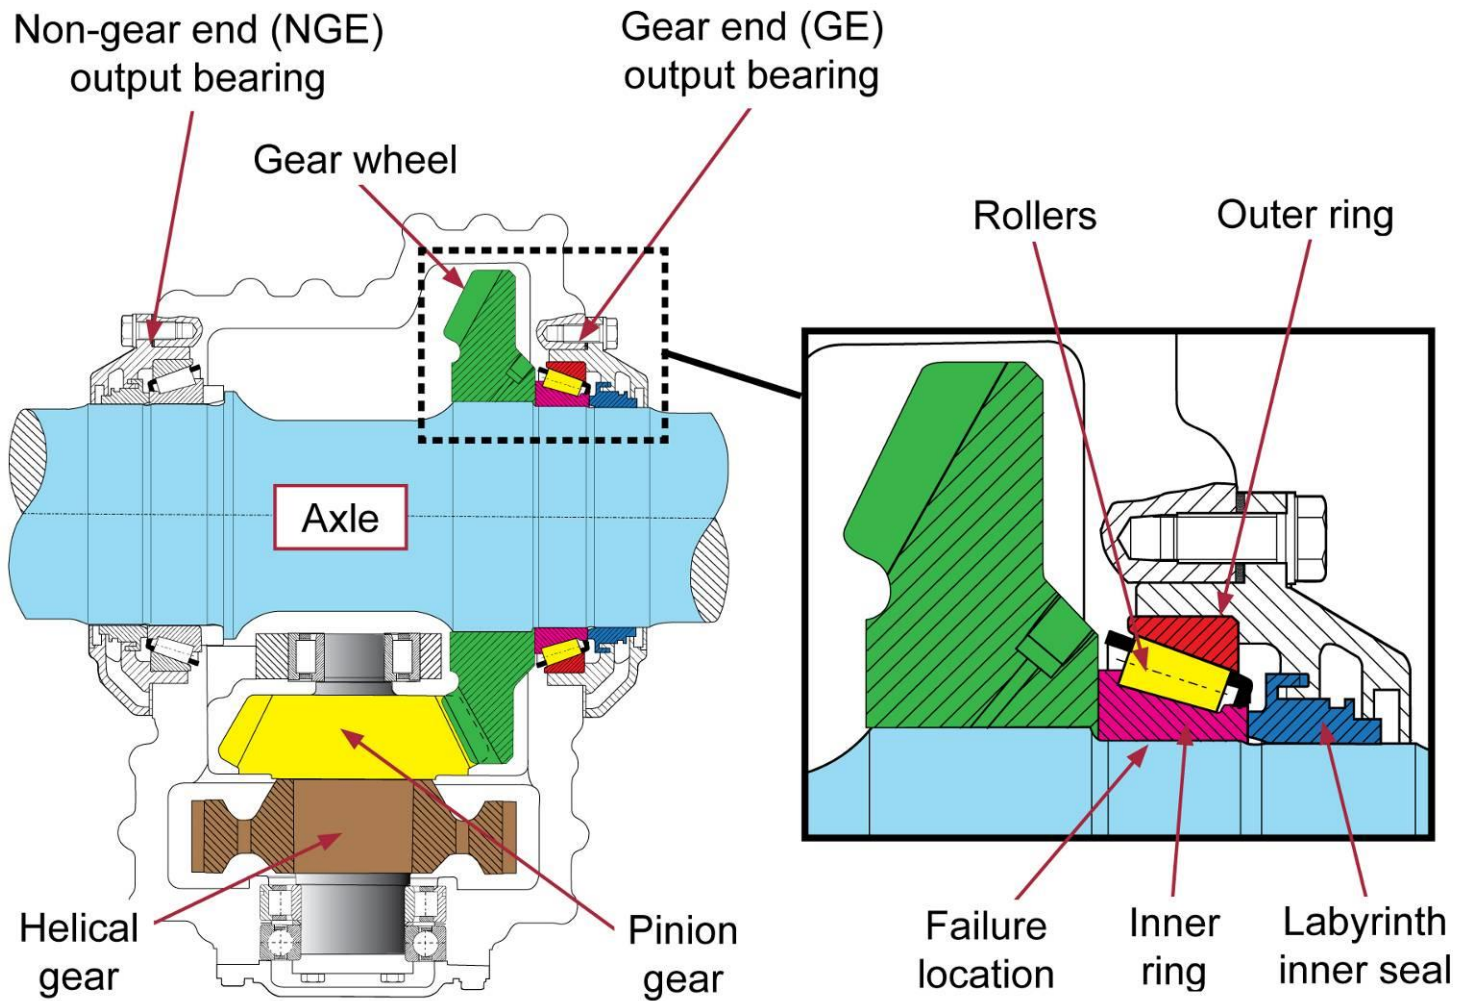
Failed GE output bearing

- Axle fracture caused by rapid overheating
- Overheating caused by spinning of the axle within the inner ring of the GE bearing, which had become stiff.
- Bearing probably became stiff due to a clearance which had developed between the inner ring and axle.
- Likely causes of clearance:
 - Design fault resulted in a low initial interference fit.
 - Progressive loss of bearing interference fit in service due to bore growth and fretting wear.
 - Bearing seat on axle may also have been manufactured undersize.
- Also train operation issues – train took 2 miles to slow down after bogie warning light

1. Design review of Meridian/Voyager gearboxes to reduce the risk of recurrence. (Train and gearbox manufacturer)
2. Review and improvement of design, manufacture and overhaul procedures for final drives on other fleets, to ensure lessons from EL are built into industry practice (ROSCOs and other CEs, maintainers).
3. Review and optimisation of final drive oil sampling regimes for Meridian and similar fleets to improve failure detection capability (Train maintainer)
4. Practical rolling stock specific refresher training, including simulation, for drivers and train crew on handling emergencies. (Train operator)

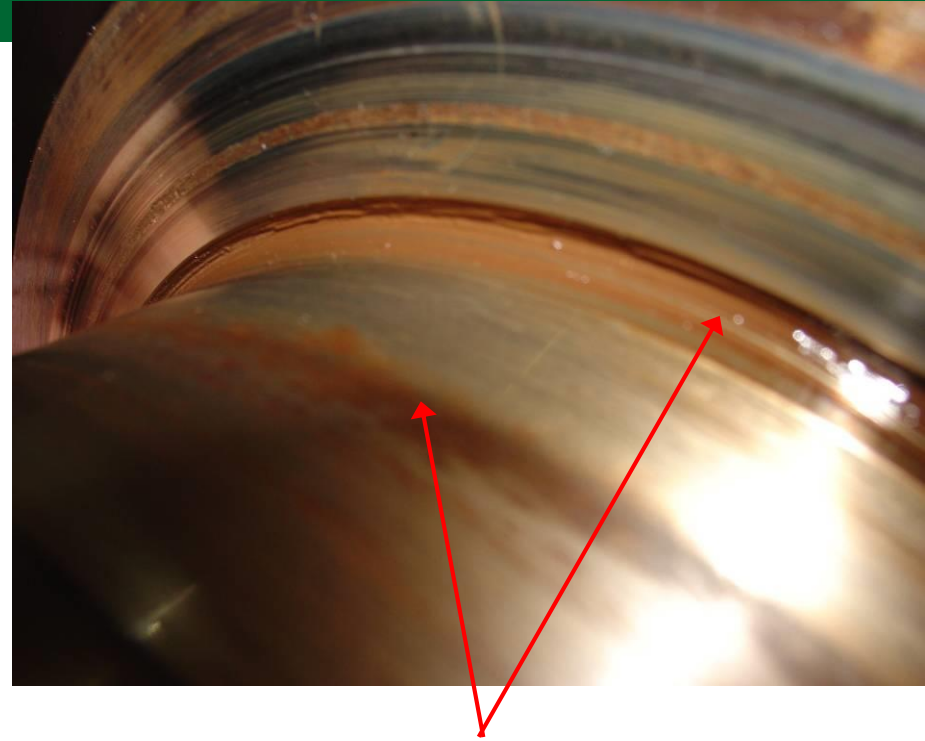
- Inadequate bearing fits can lead to complete loss of interference and even clearance.
- 3 mechanisms:
 - inner ring growth
 - fretting
 - inner ring creep
- Once inner ring creep starts, fretting wear is accelerated, potentially leading to clearance.
- 3 wheelsets found with clearance (and severe fretting (see photo)).
- 2 wheelsets found with low interference

Reddish brown fretting residue found on axles with axle/inner ring clearances

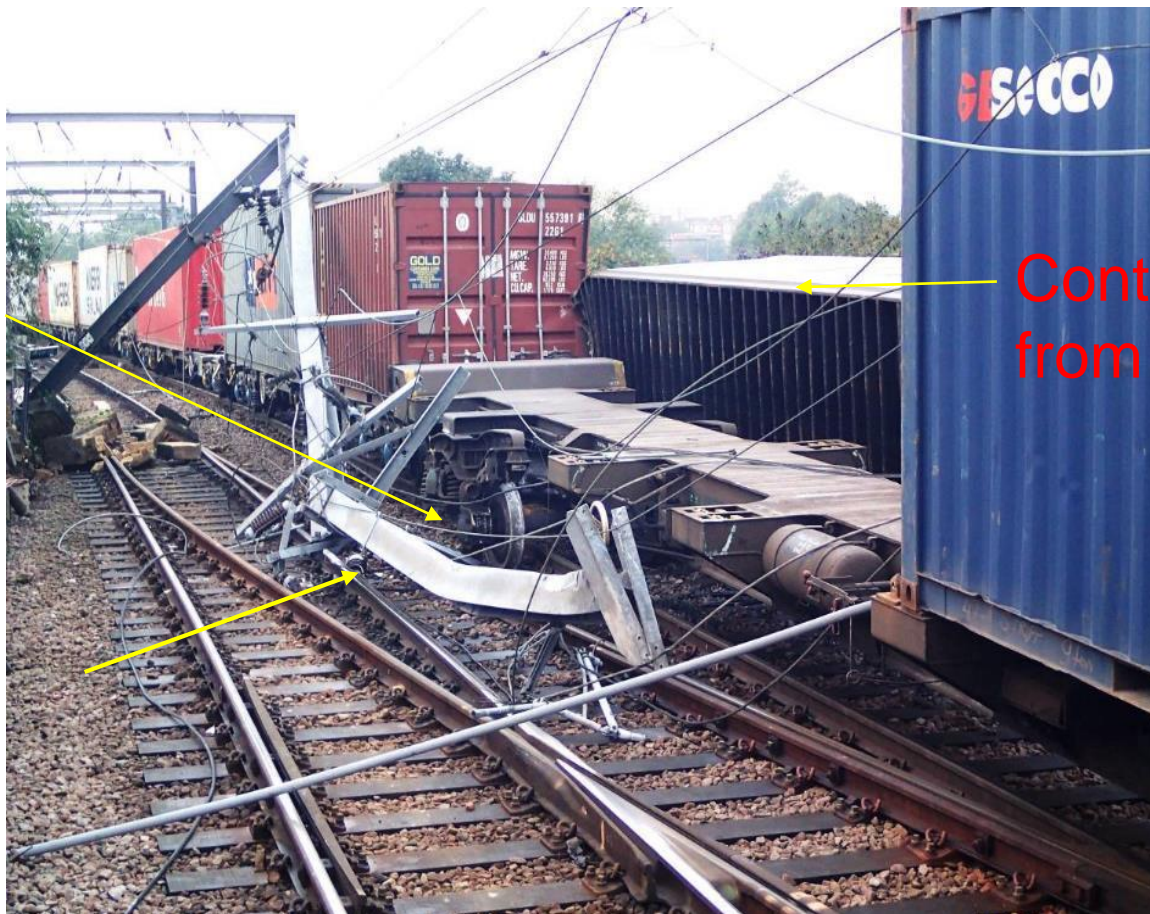
Derailed
bogie

Container fallen
from wagon

Collapsed
overhead line
equipment

Derailed wagon

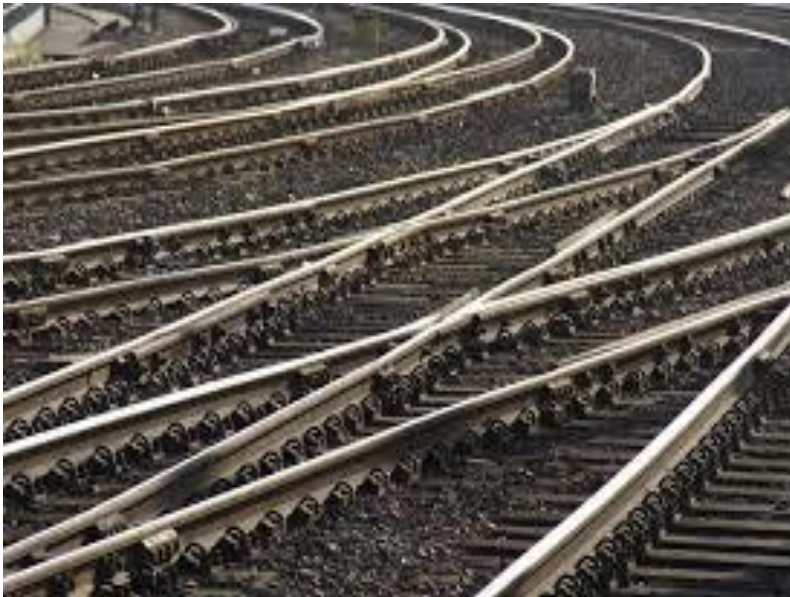
The track: multiple, opposing, twist faults

- Track twist measured over 3 metres - intervention regime based on this
- 3 metre-track twist at point of derailment required intervention within 7 days (not block the line)
- Wagon has axle centres at 2 metres (on each bogie) and bogie centres at 14 metres
- Filtering track survey data for 2 and 14 metre wavelengths shows a completely different picture (next slide)

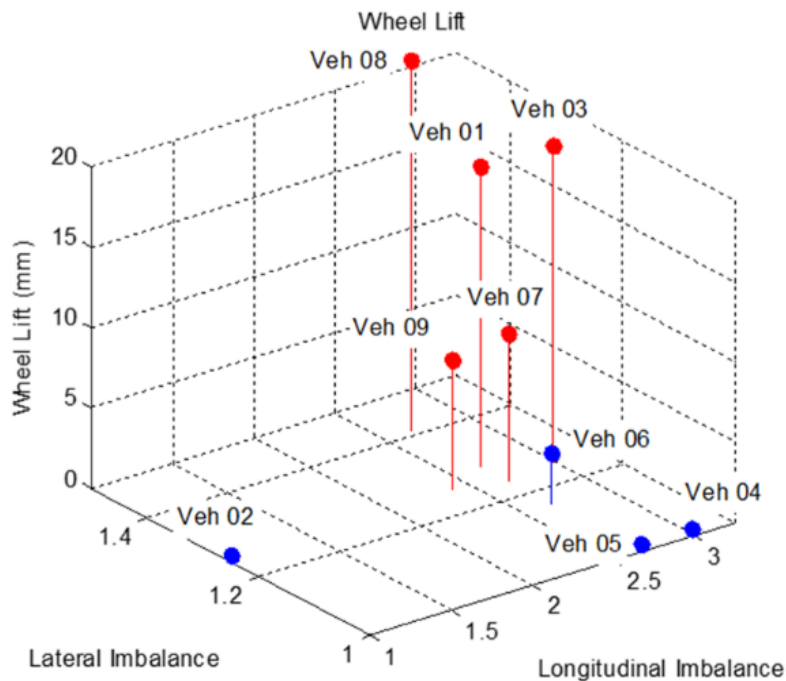
Results: $\mu = 0.23$

Key criterion
Wheel lift in excess of 6mm implies derailment

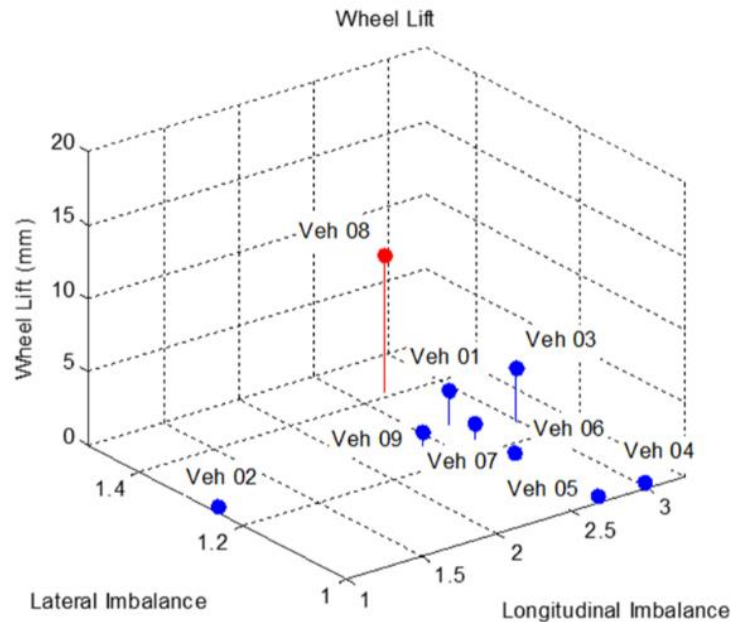
Reduced track twist

- Track twist reduced to 75% of measured value
- Wheel lift in excess of 6mm implies derailment
