INSTITUTION OF MECHANICAL ENGINEERS HONG KONG BRANCH  
EVENING LECTURE “PUBLIC ANTIQUE” ON 13/3/2017

# IMechE Seminar: Public Antique

## Classic Bus Restoration & Preservation in Hong Kong

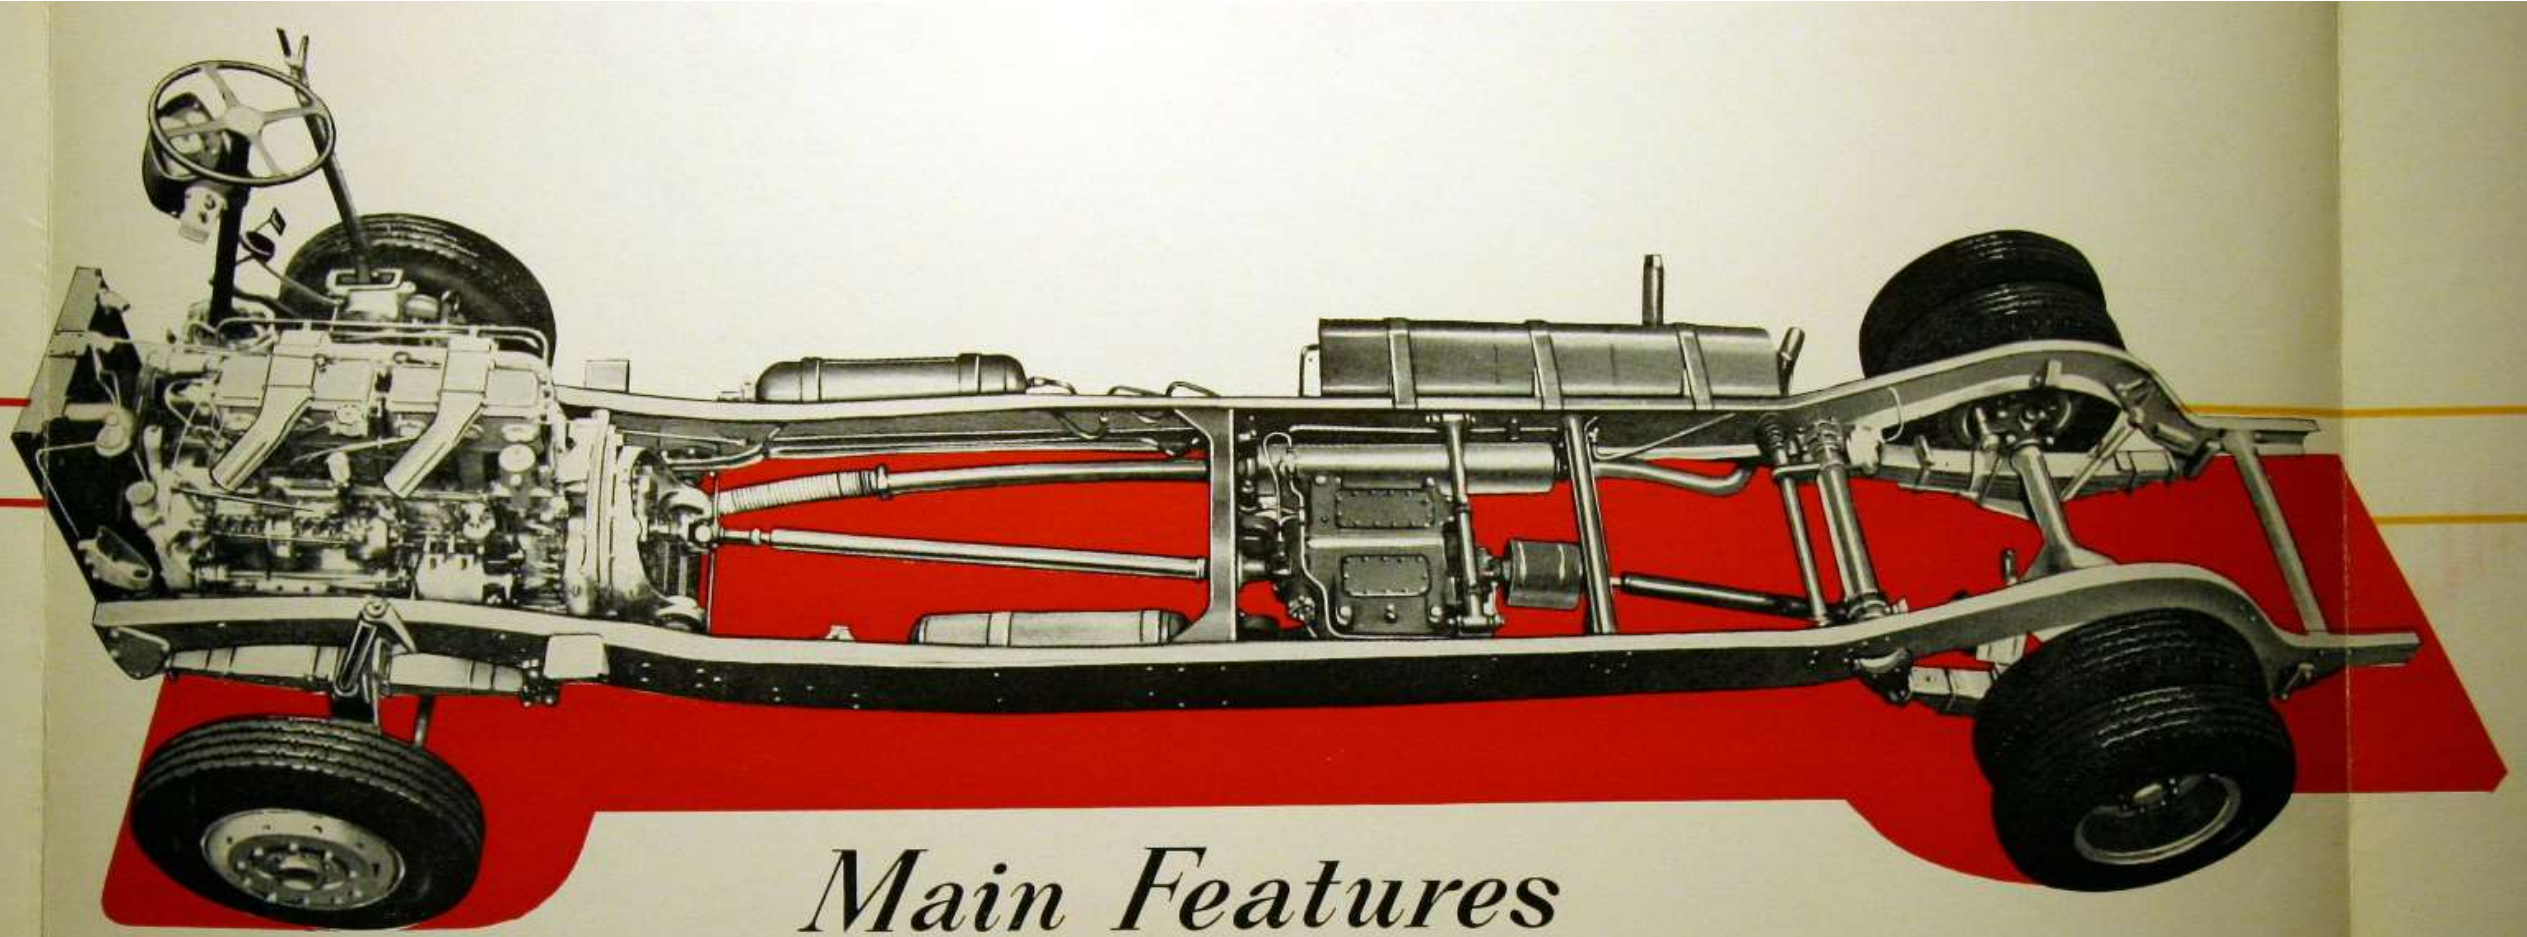
# Restoration process – Chassis

*Main Features*

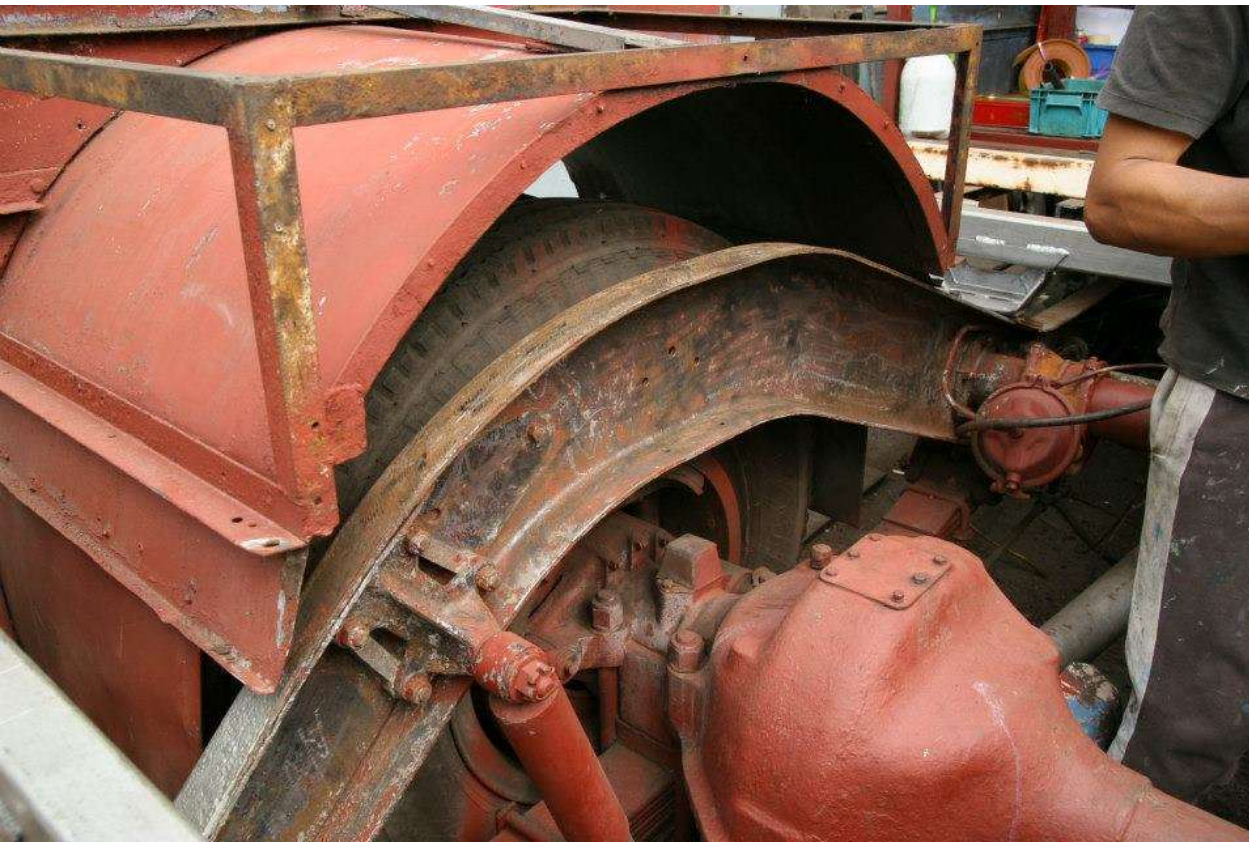
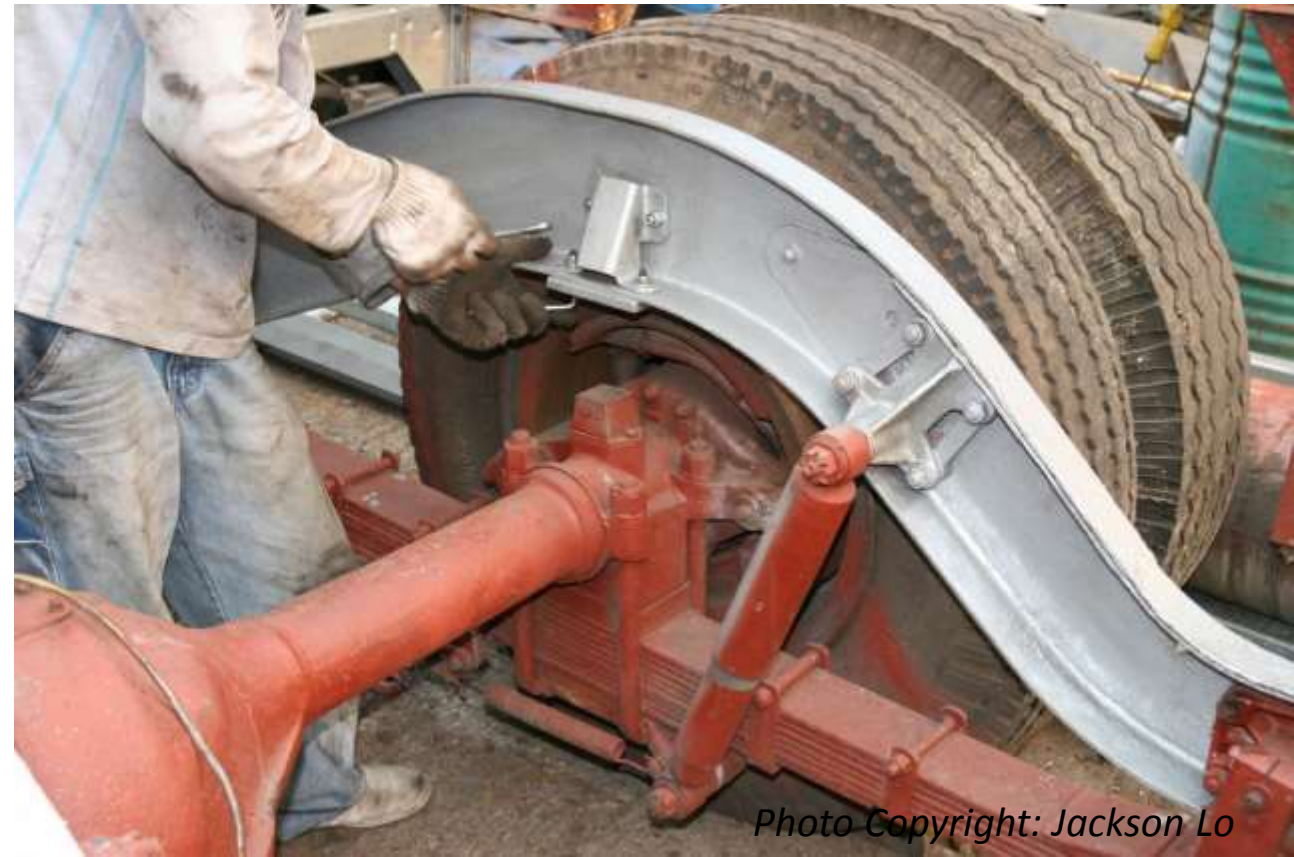
# Restoration process: Chassis Rust-proofing works

The chassis frame was badly corroded upon receipt of the vehicle by the owner. After removal of the original bodywork, the chassis frame was sand-blasted for rust removal and subsequently repainted for corrosion protection.

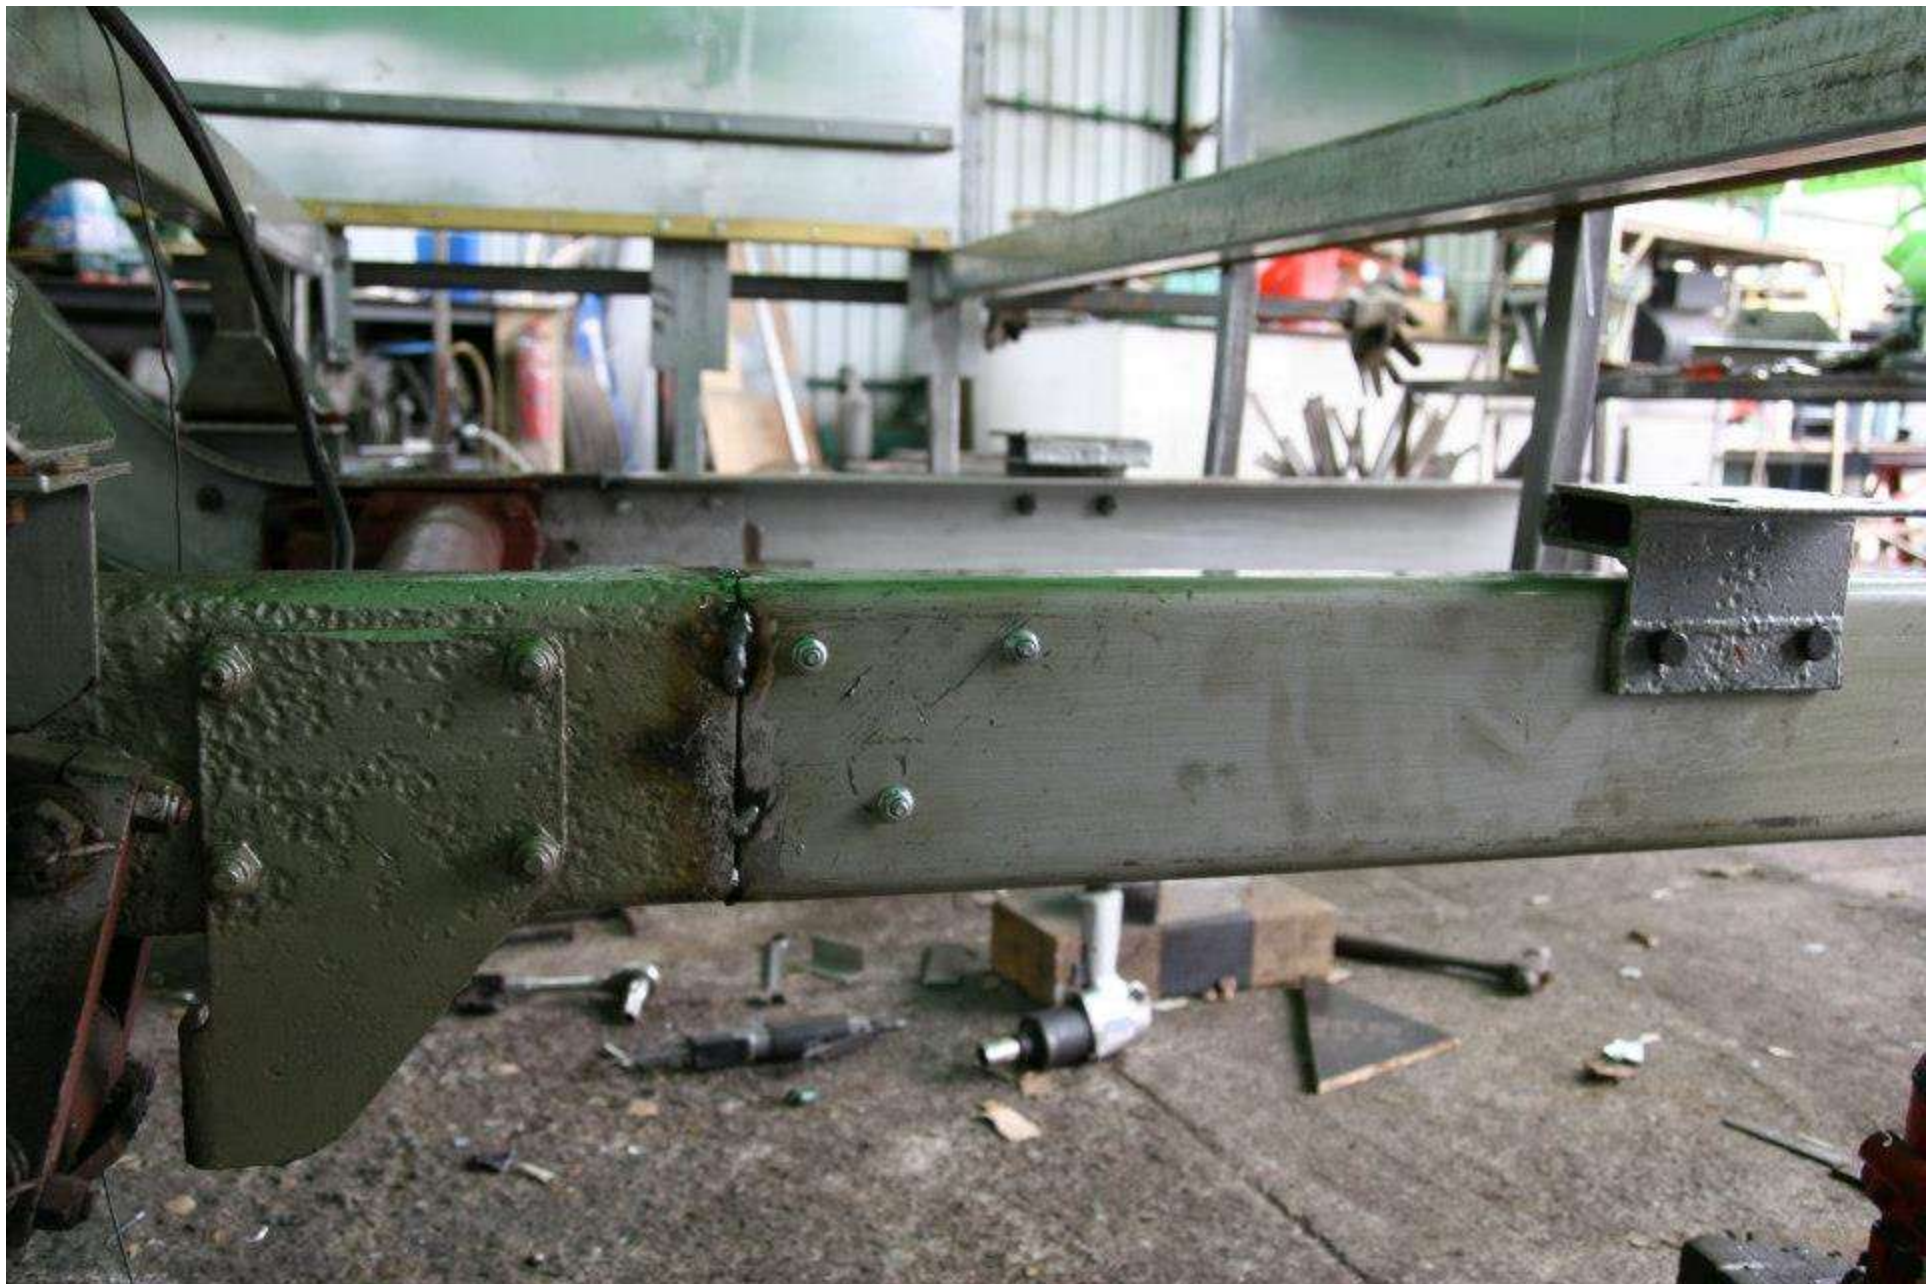
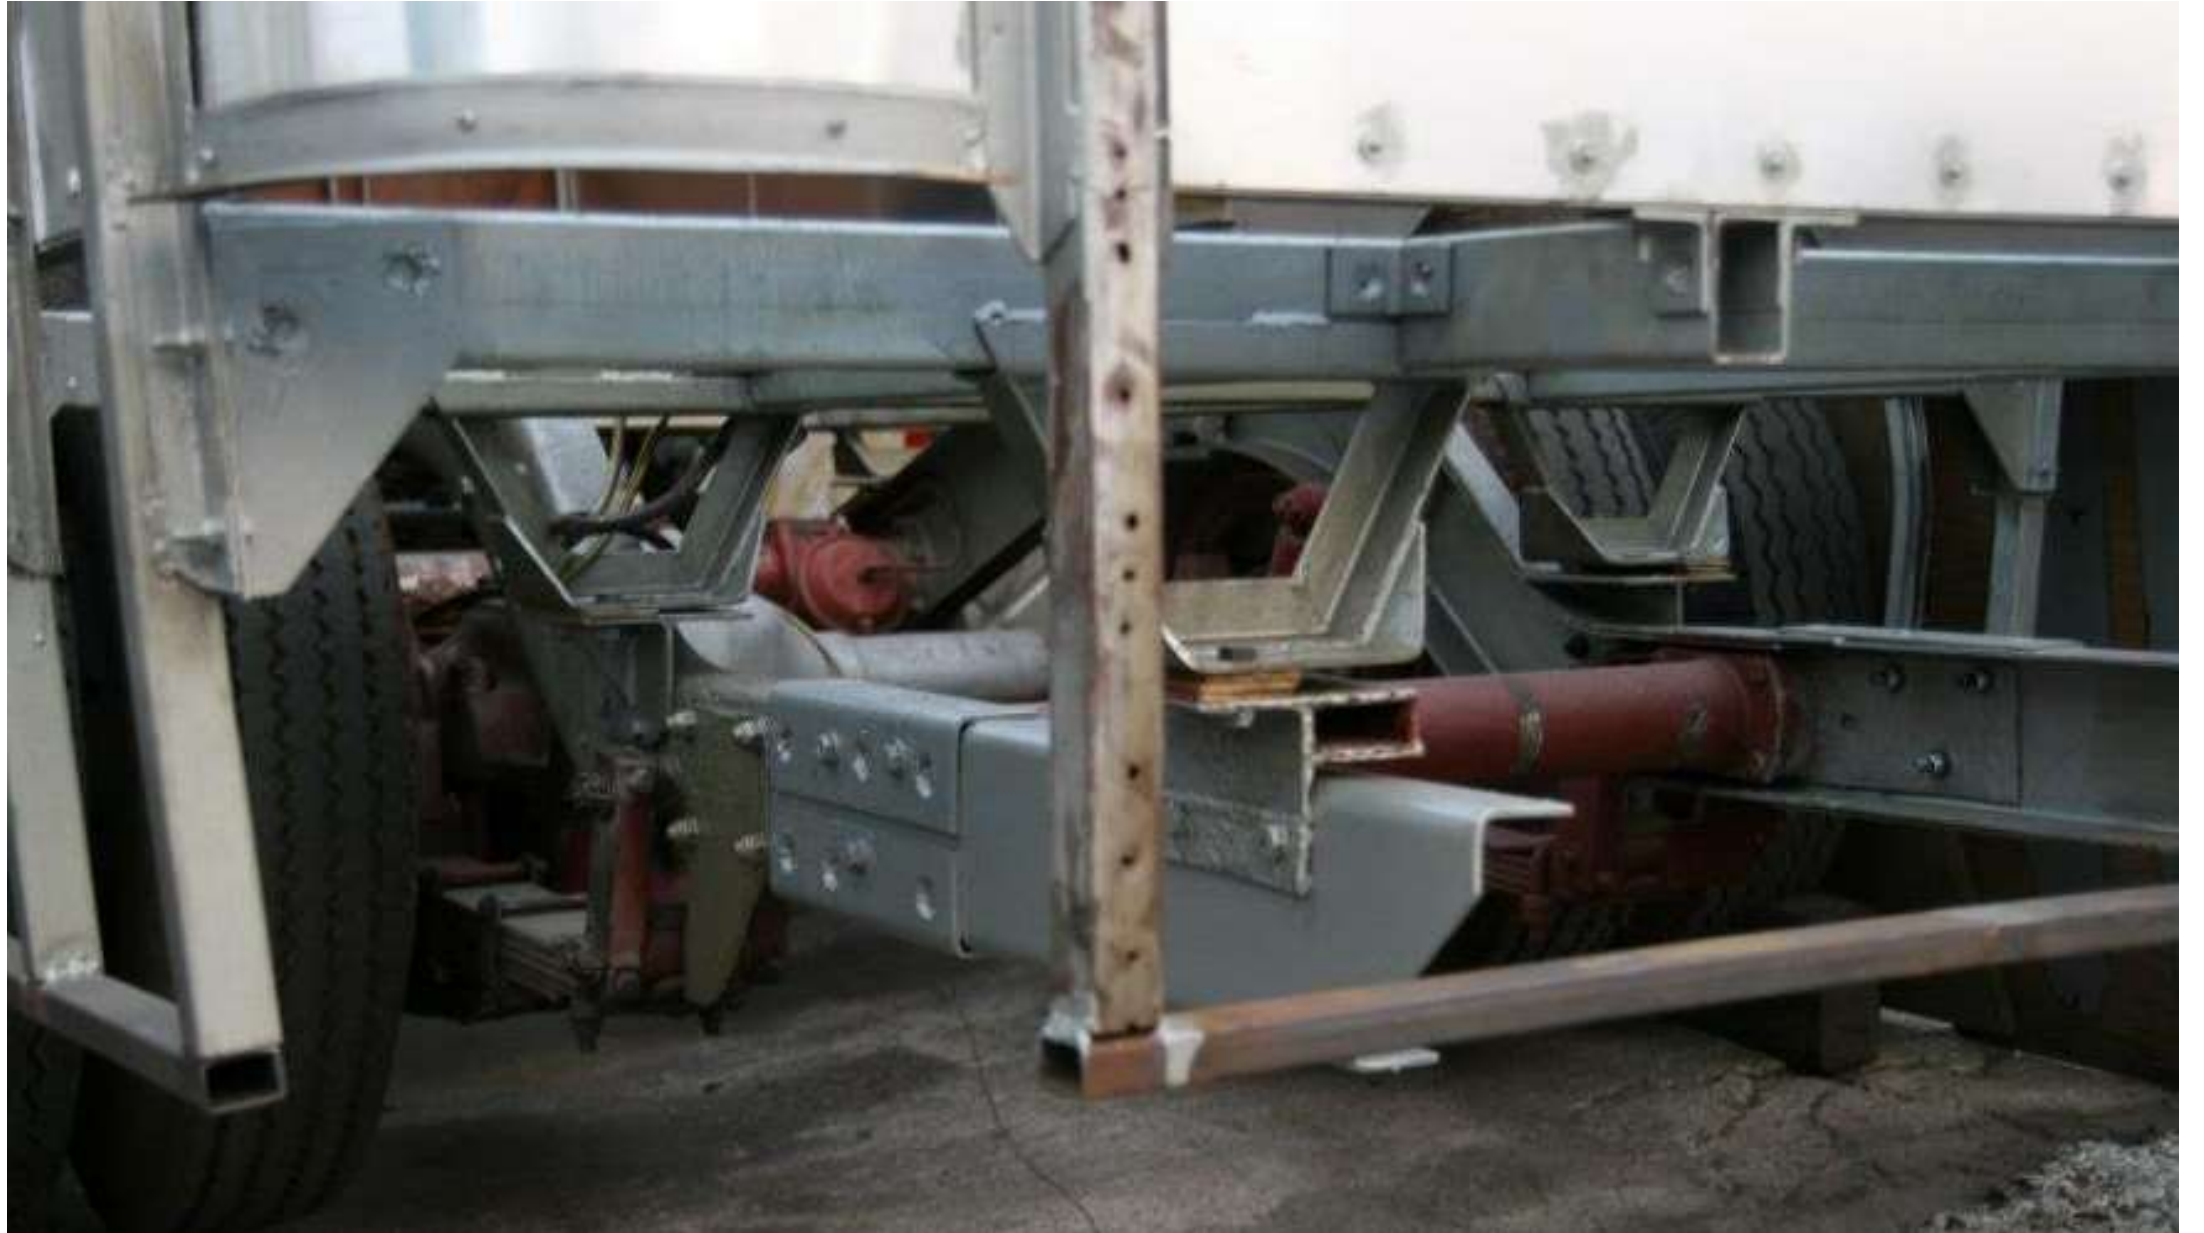
**Fillet Weld in a Hole**

Upon conversion to a tow truck the chassis rear over-hang was cut short, which gave rise to the re-provision of the shortened chassis for the reconversion to a bus. C-channels in the same dimensions as the chassis main frame were used to provide the extended length and they were connected to the chassis main frame by means of plug welding. For each of the two main chassis members, a reinforcing pad with a hole was provided and placed on the inner flange of the existing C-channel member, with the hole facing the chassis centreline. Fillet weld was applied at the hole joining the existing C-channel member and the pad. The inner flange of a new piece of C-channel (for extension of the chassis frame) was then placed against the pad and the outer flanges of the existing C-channel member and the new piece of C-channel were then covered by two L-plates, with one on the top and the other at the bottom, for increasing the bending strength of the extended chassis frame. Finally, the pad, the existing C-channel member, the new piece of C-channel and the L-plates were mechanically fastened together by bolts and nuts. With this installation technique,

albeit empirical without in-depth design calculation, the extended piece of chassis frame joined to the existing chassis frame by minimal welding work and the extension has been found effective. The extension provided support for the rearmost cross member and the rear part of the bus bodywork.

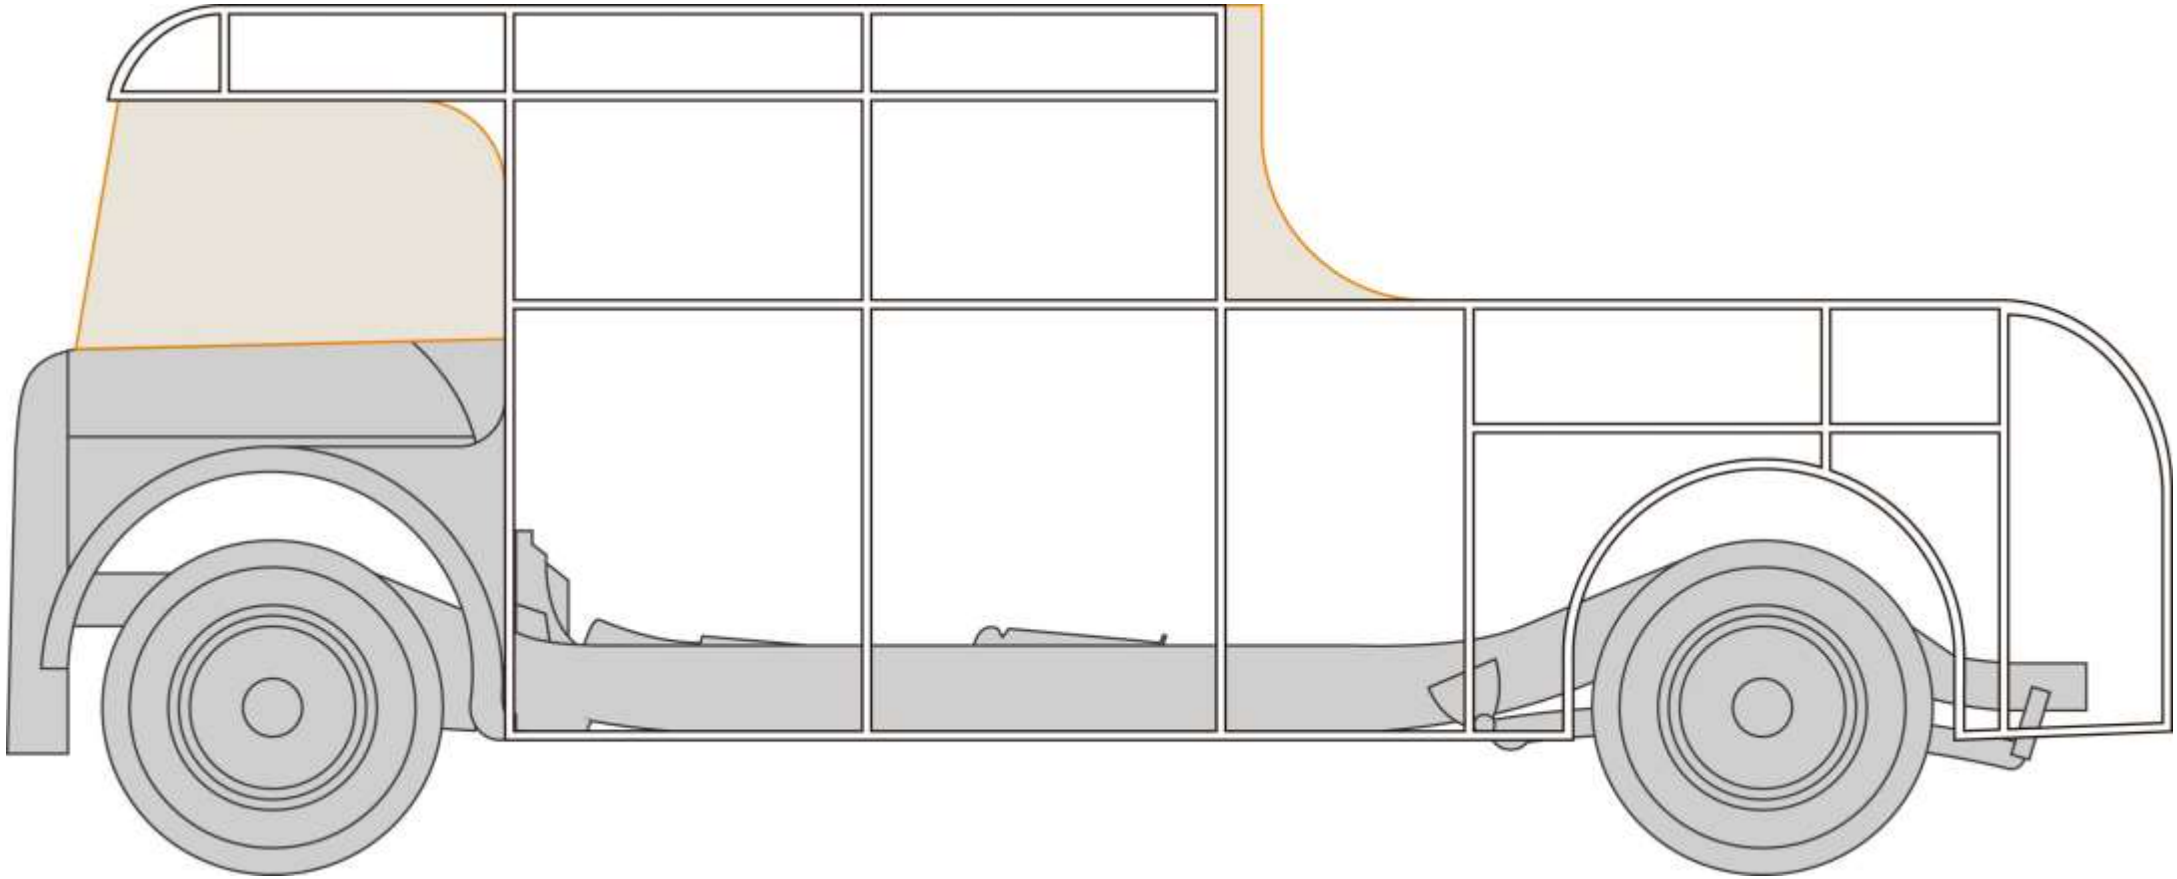
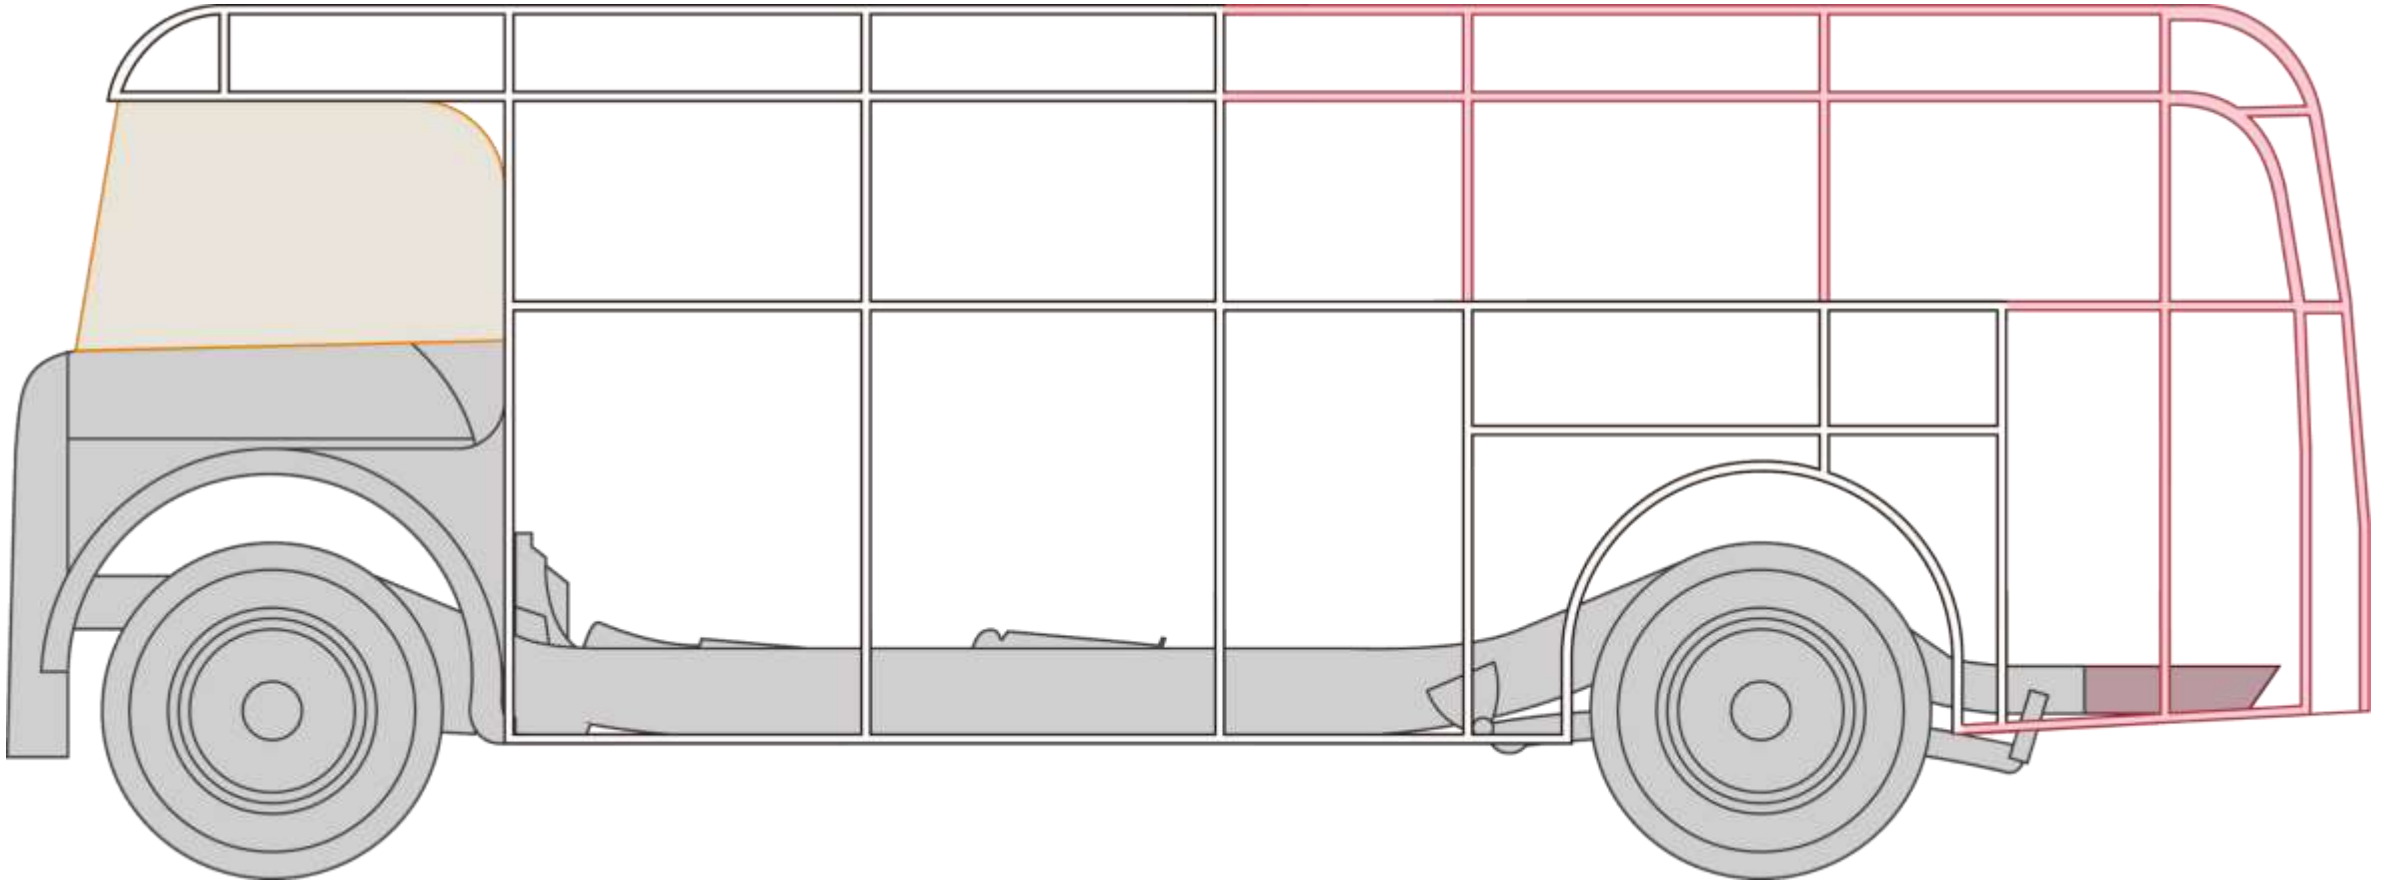
# Design 1: Partial Rebuild

- Weaker body strength at joints  
(Especially above nearside centre door cant rail and rear body)
- Different materials causes uneven body weight distribution
- Difficulties in building a correct body shape geometry

In spite of being a tow truck, the original bodywork inherited certain features of the vehicle when it was a bus. This permitted the bodywork rebuild to adopt a partial approach, which meant the existing bodywork could be utilised with the new bodywork installed only for the missing part. Although this would have benefits of lower production cost and shorter production time, the drawbacks of weaker resulted body strength at joints, uneven body weight distribution and difficulty in achieving a correct body geometry prompted a complete rebuild to proceed with. The weaker body strength was particularly an issue because, as the nearside waist rail gave way to the doorway, the nearside centre door cant rail was a salient longitudinal load-bearing member of the body, and asymmetry of the nearside centre door cant rail in material would compromise the overall structural strength. As a result, a complete rebuild, which provided consistent and adequate body strength, was carried out by a contractor at a corner of a garage where the vehicle was docked and a brand new bodywork, with the right doom-shape cross-section and roof profile with reference to the original tow truck roof-stick, was constructed ready for installation onto the cross members.

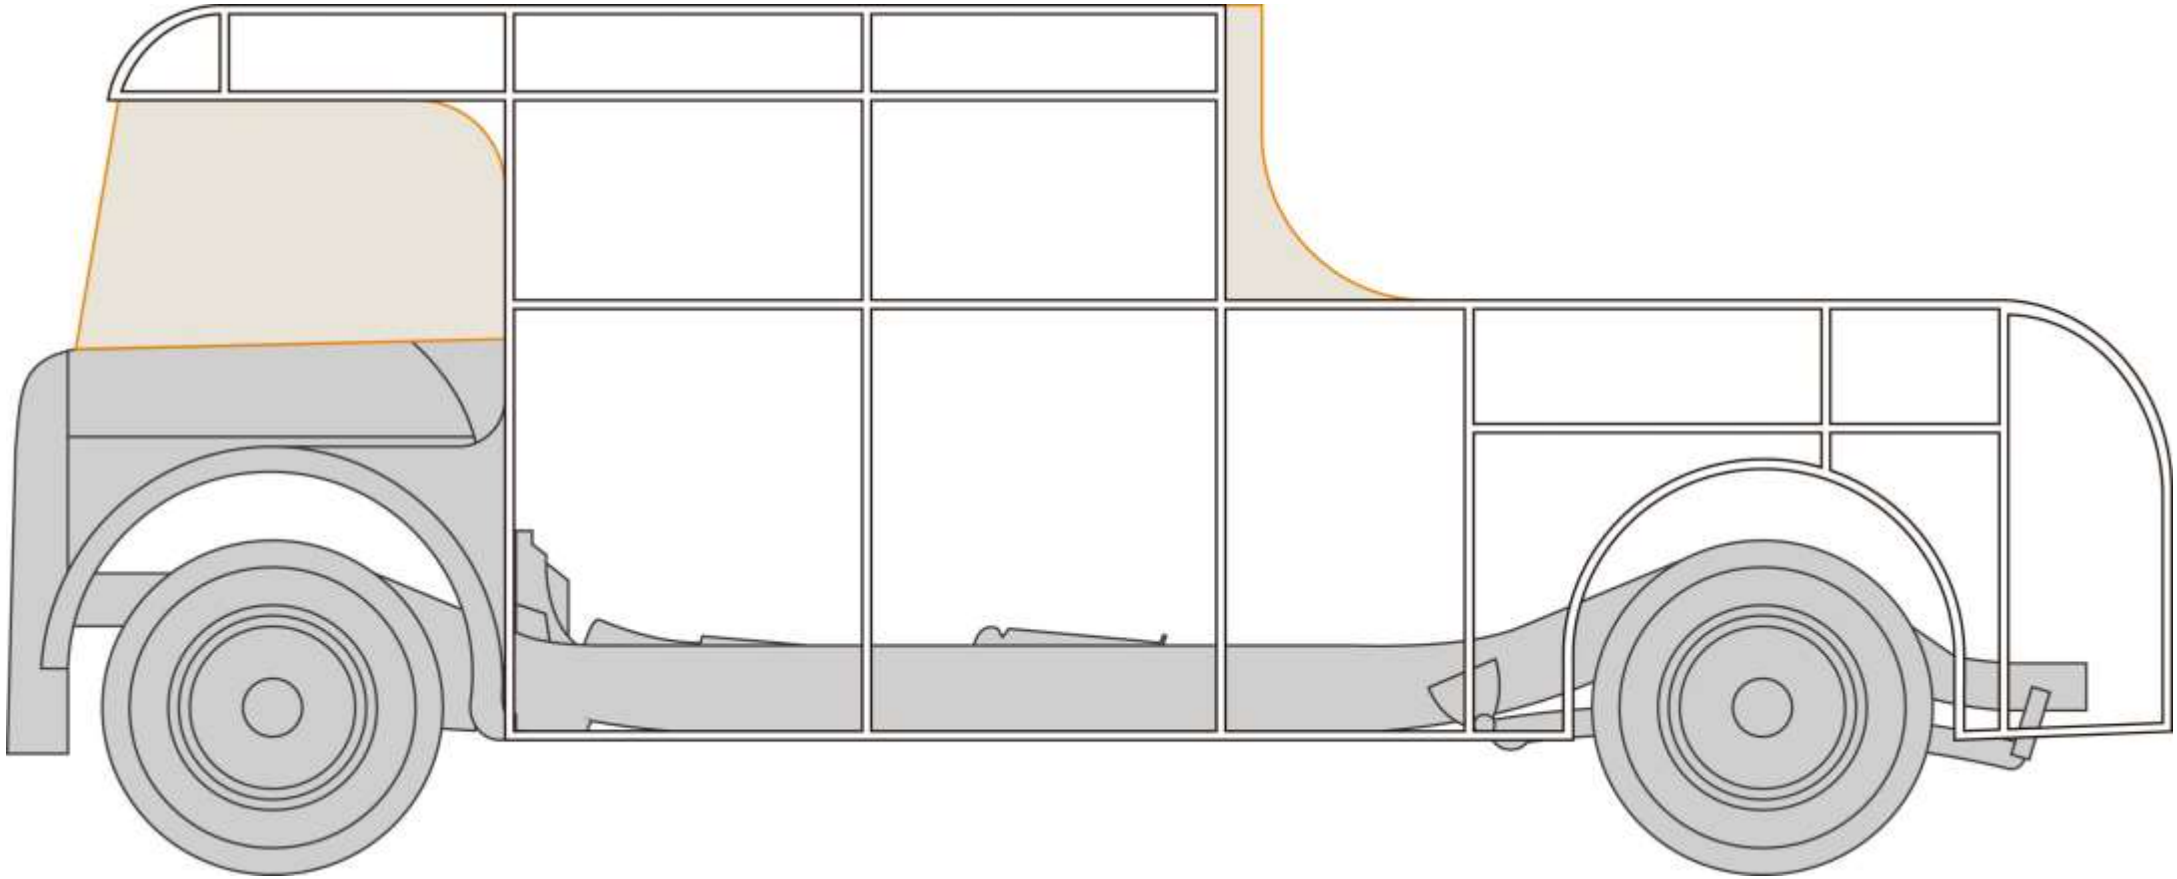
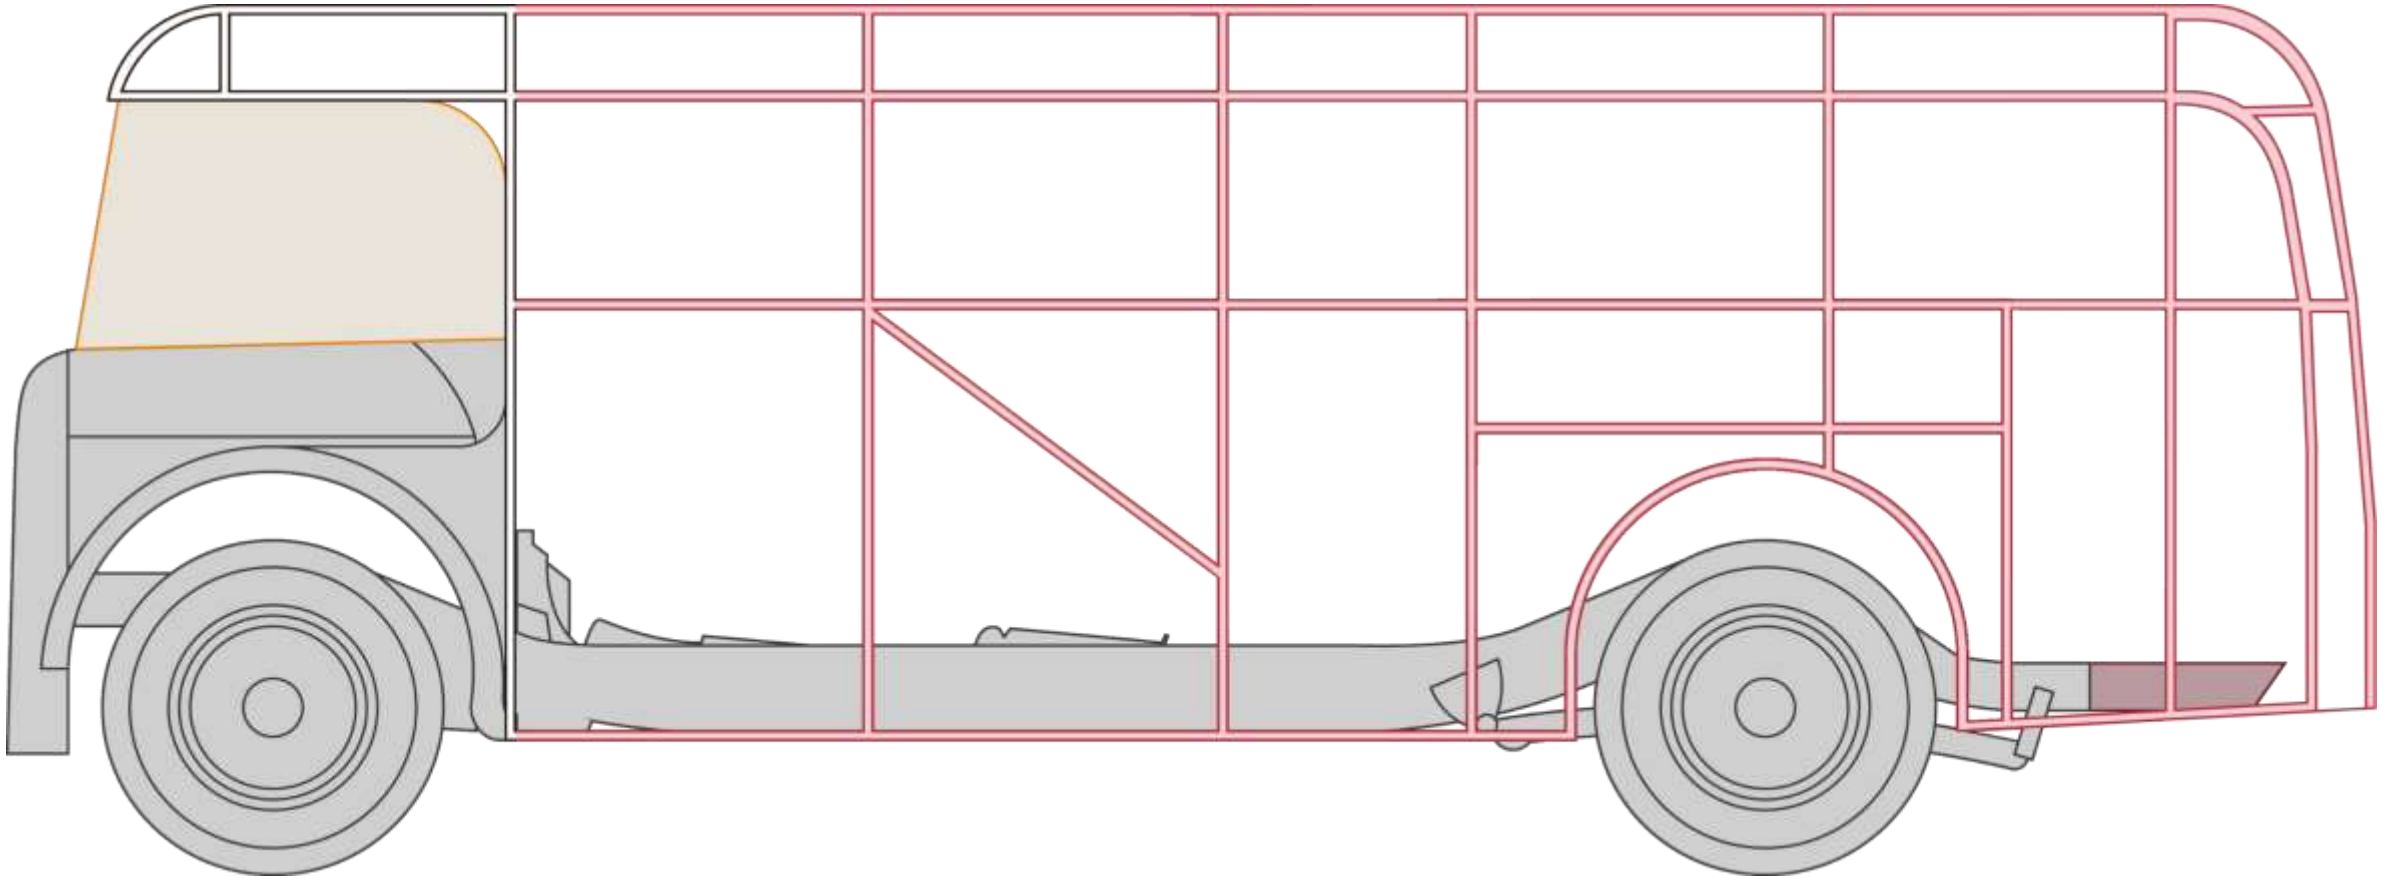
# Design 2: Complete Rebuild

**Higher production cost**

**More time and space for body build works**

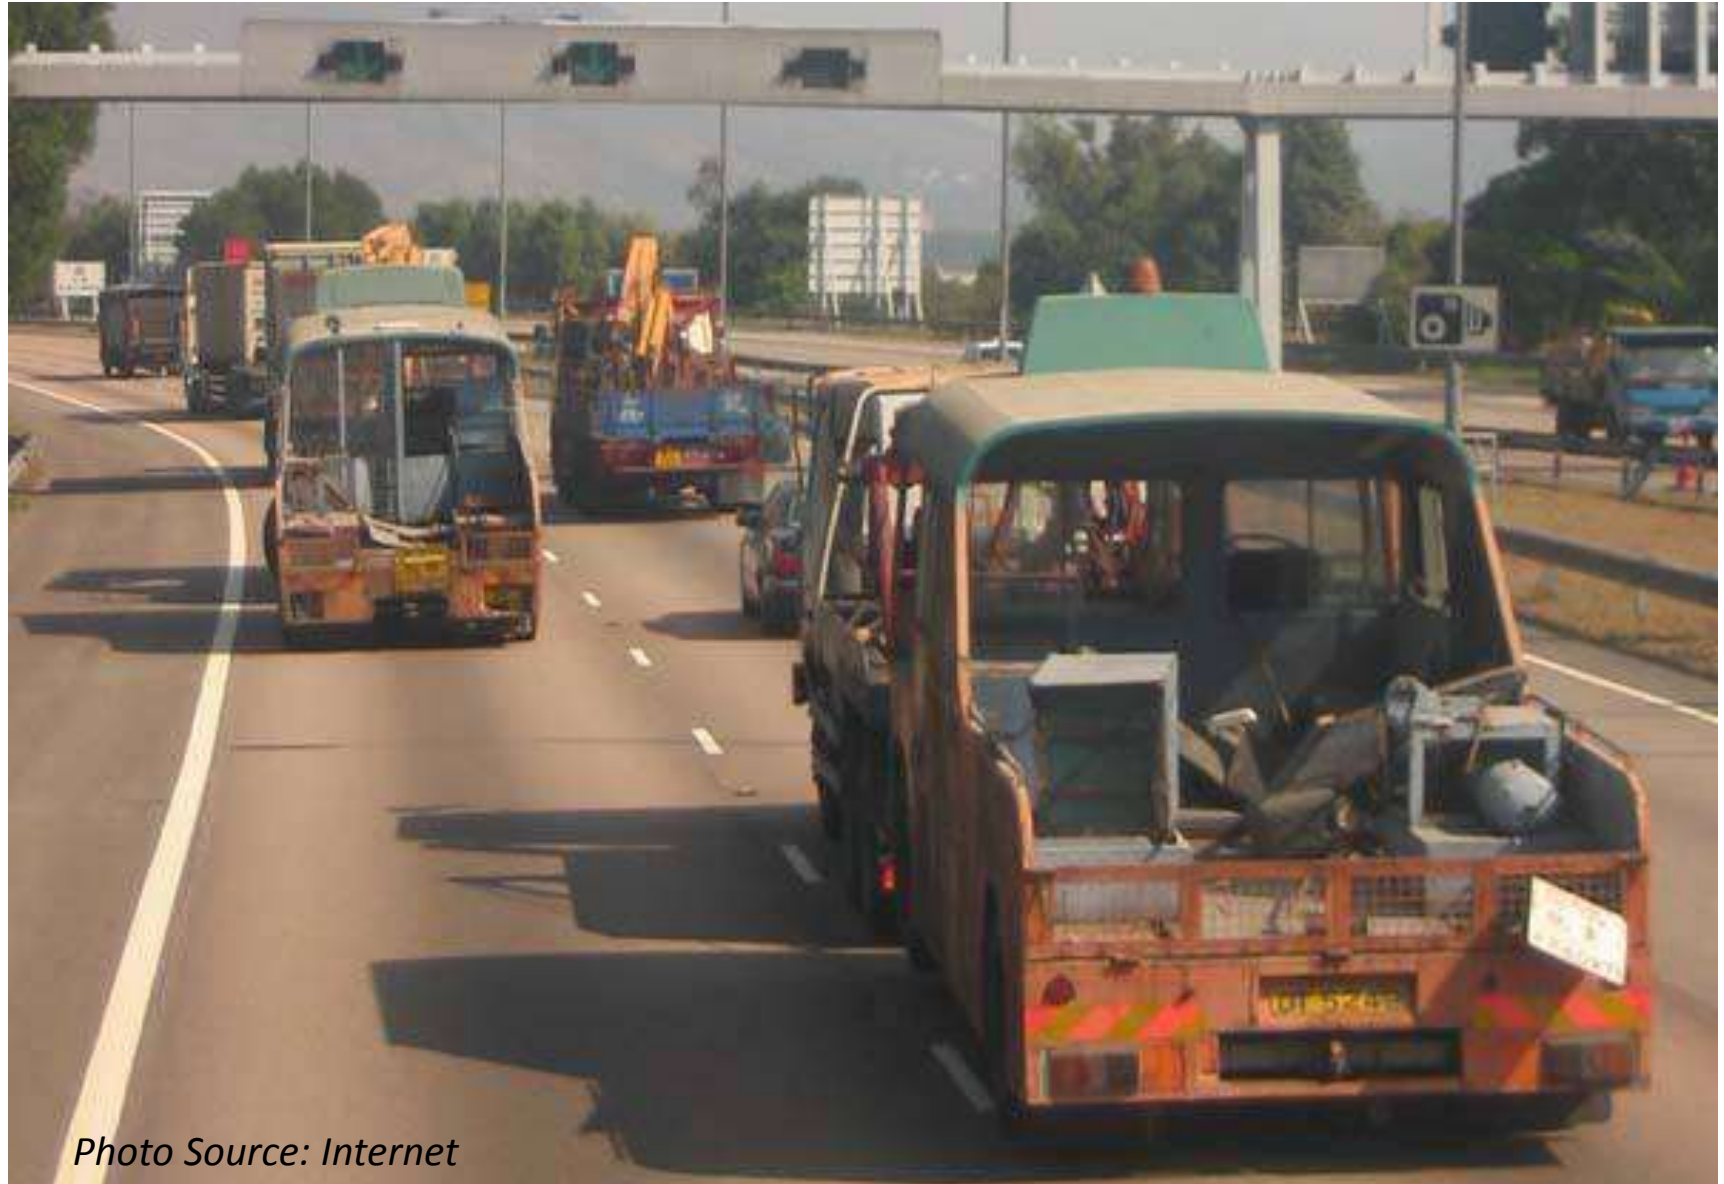
**Towing without removing the drive shaft is fatal to the gearbox.....**

The mechanical parts of the vehicle underwent extensive operation. When the vehicle was towed to the scrapyard, the drive shaft remained engaged to the rear differential thus linking with the gearbox. As a result, all gears inside the original SCG GB340 gearbox, which was technically advanced at the time of production with epicyclic gear trains fitted, were worn to nothing and the original gearbox was beyond repair. It was however fortunate that a reconditioned gearbox of the same model could be sourced from the U.K. and installed, equipping the restored bus with a new transmission set. Salient lesson learnt is, therefore, that the drive shaft should be disengaged from the differential and gearbox prior to towing the vehicle.
