INSTITUTION OF MECHANICAL ENGINEERS HONG KONG BRANCH  
EVENING LECTURE “PUBLIC ANTIQUE” ON 13/3/2017

# IMechE Seminar: Public Antique

## Classic Bus Restoration & Preservation in Hong Kong

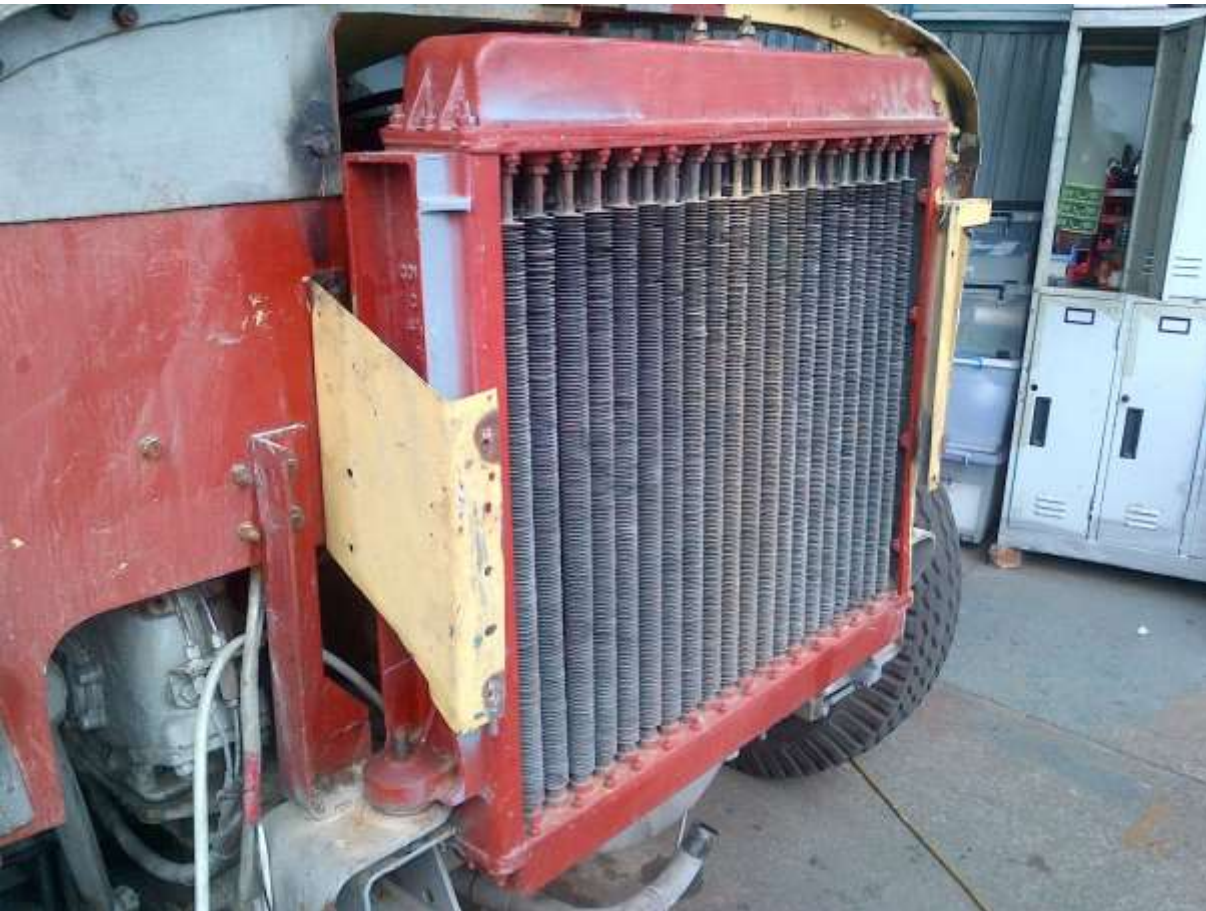
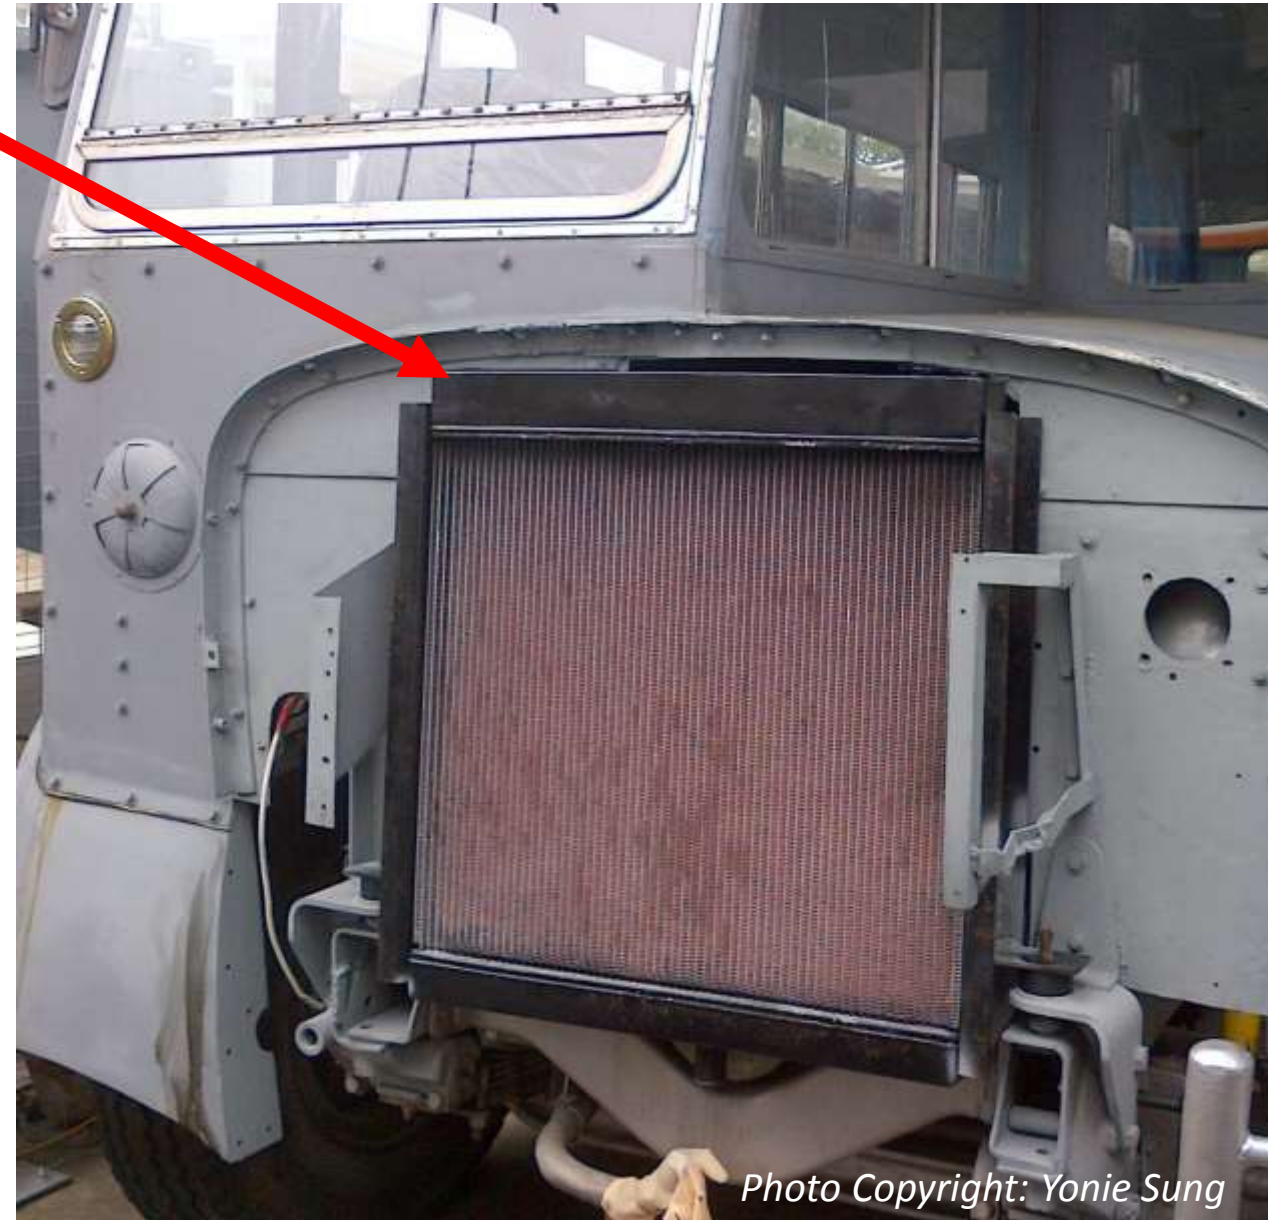
**Aluminium radiator  
replaced provides better  
cooling efficiency**

The original radiator was inadequate for cooling of the engine. The fins on the brass-made cooling tubes were severely clogged and the effort of removing the dust and dirt would be excessive. Considering that the radiator would hide behind the front grill and out-of-sight, notwithstanding loss of originality, it was compromised to replace it with an aluminium-made one which could offer a higher heat transfer efficiency and thereby addressing the cooling shortfall at the root cause conveniently.

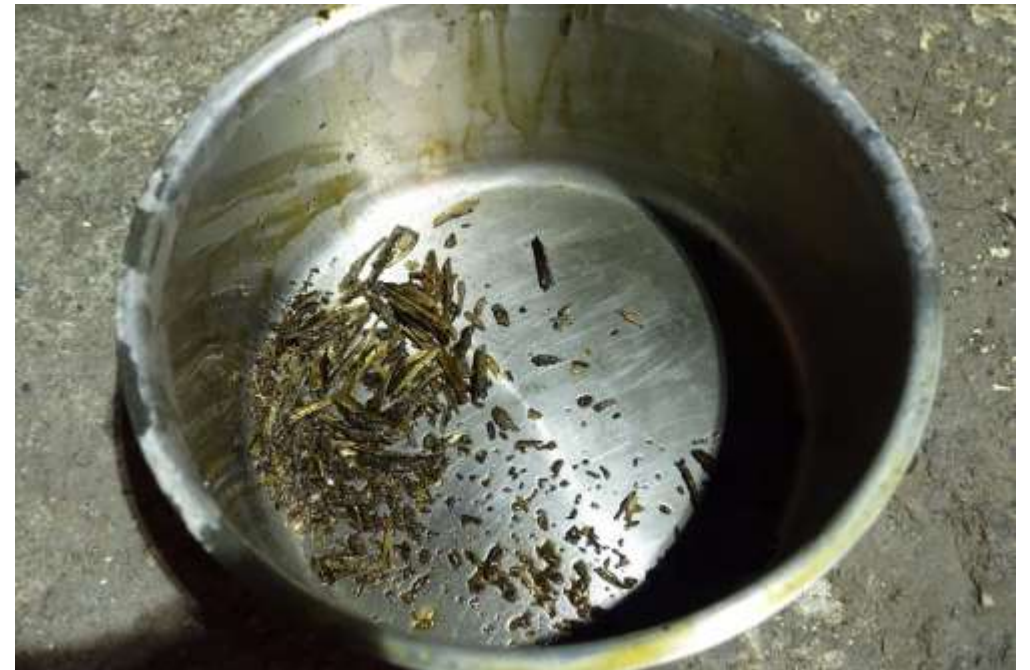
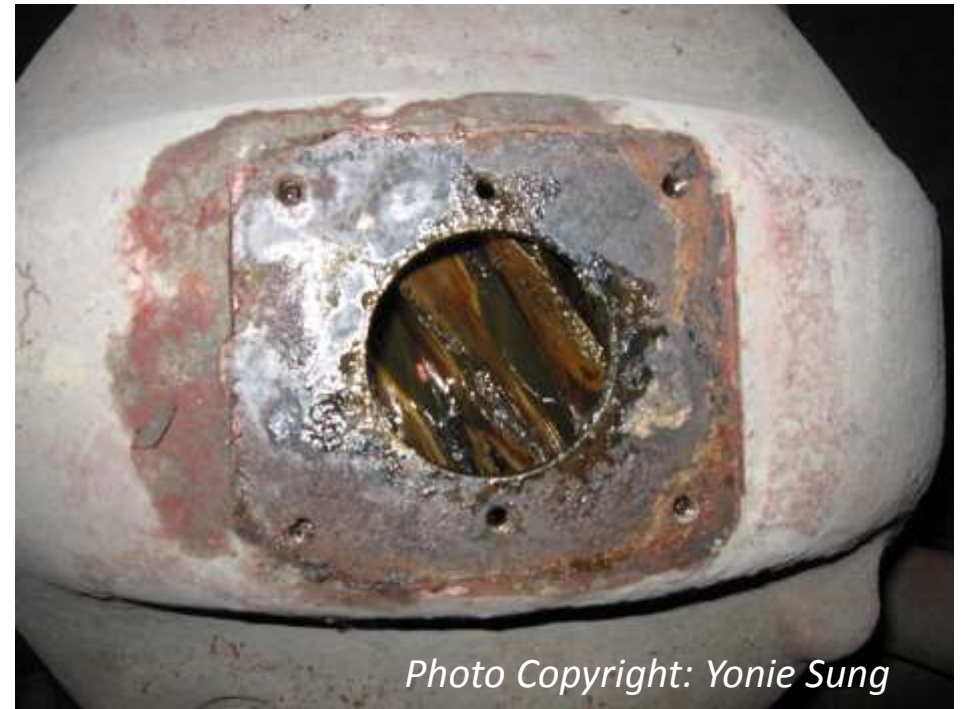
# Brass corrosion on Rear Differential Gear

Modern gear oil with Extreme Pressure (EP) and anti-wear additives prevent metal-to-metal contact by adding film-forming compounds that protect the surface either by a physical absorption or a chemical reaction with the metal surface in order to form a low shear film at the point of contact.

These additives containing sulfur and phosphorus compounds, which reacts and corrodes brass gear.

Unlike modern heavy duty vehicles, the worm wheel of the rear axle differential of Guy Arab V was brass-made. This salient material feature had been omitted for years, and the modern gear lubricant standard, such as API GL-5 rated in API 1560, was applied to the differentials of the entire C.M.B. fleet. The sulphur and phosphorous

compounds in the anti-wear additives of the modern gear lubricant, which either physically absorb on or chemically react with the metal surface to form a low shear film at the point of metal-metal contact, react and corrode the brass wheel. Modern API GL-5 lubricant was therefore not suitable for this Guy, and only after referecing historical literature obtained from Aston Manor Road Transport Museum archive, the suitable lubricant, which was equivalent to API GL-1 or GL-2, was ascertained. This lubricant type was no longer supplied in Hong Kong and could only be sourced and tailor-blended through a lubricant supplier in the U.K.

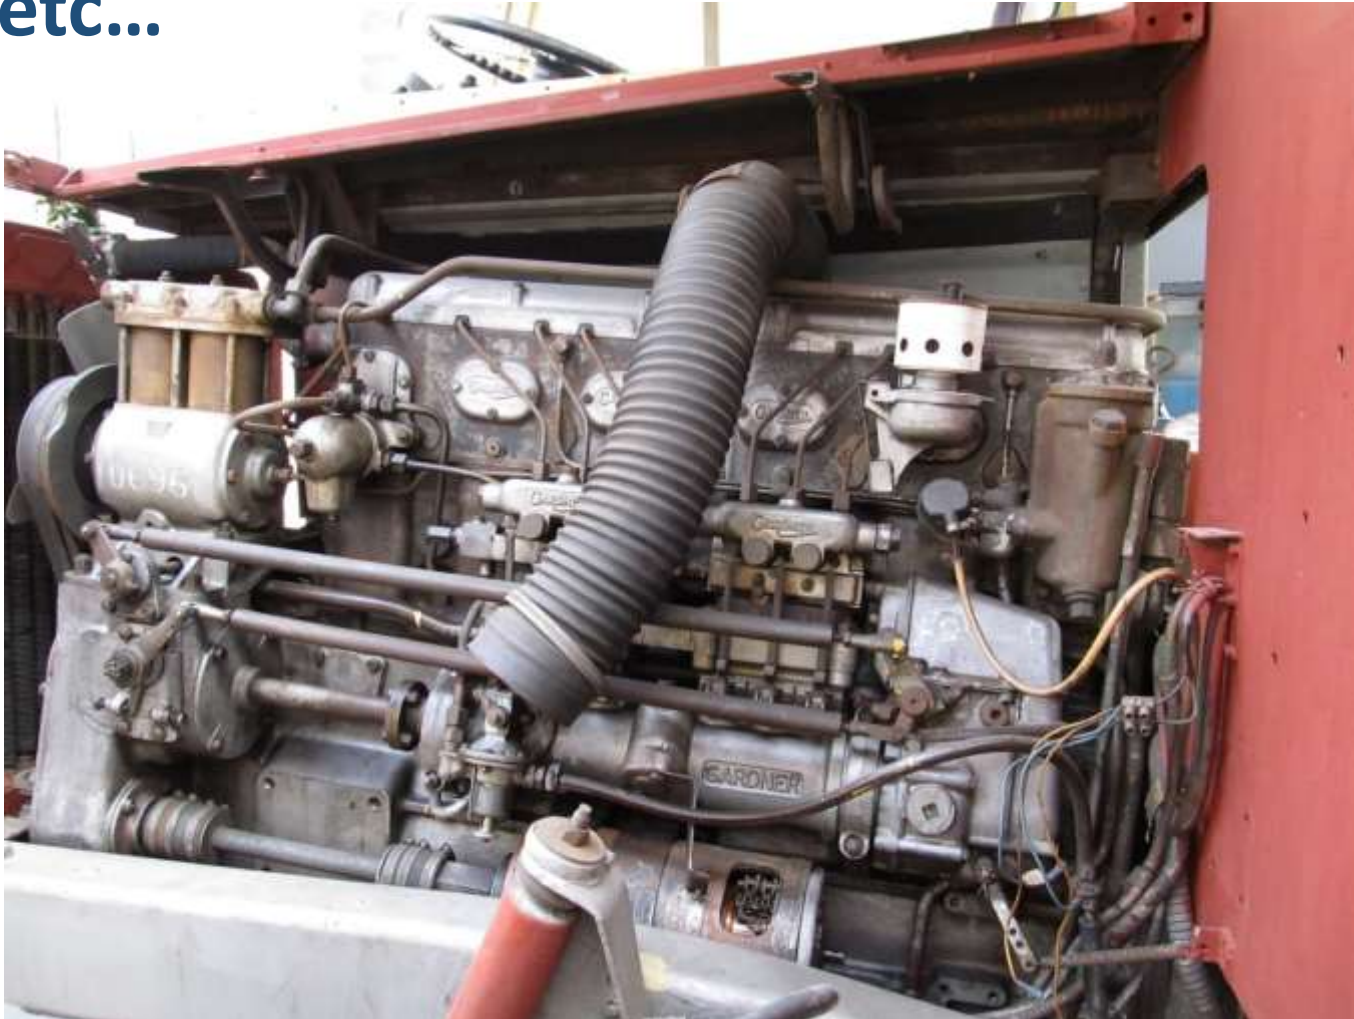
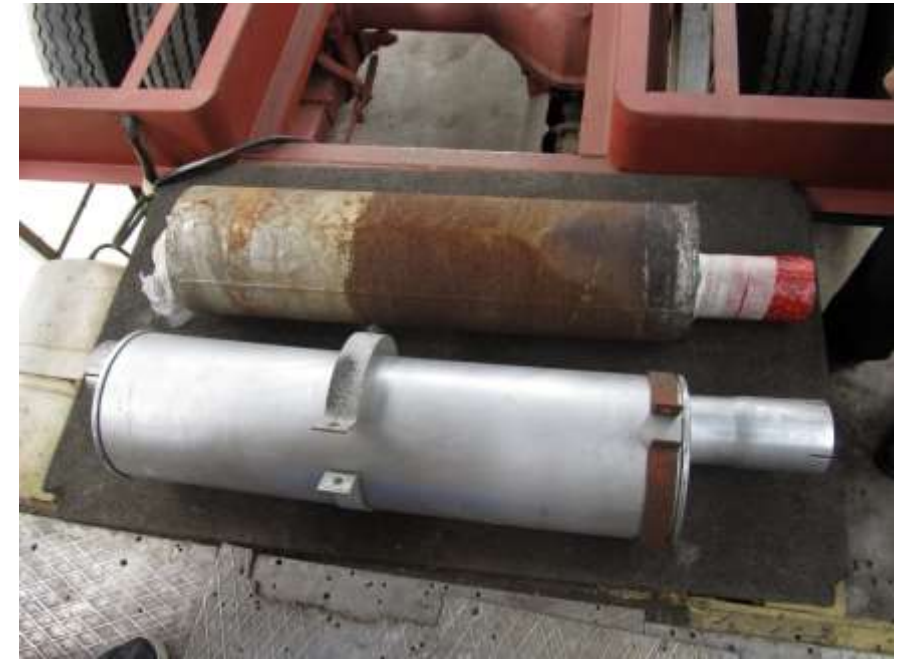
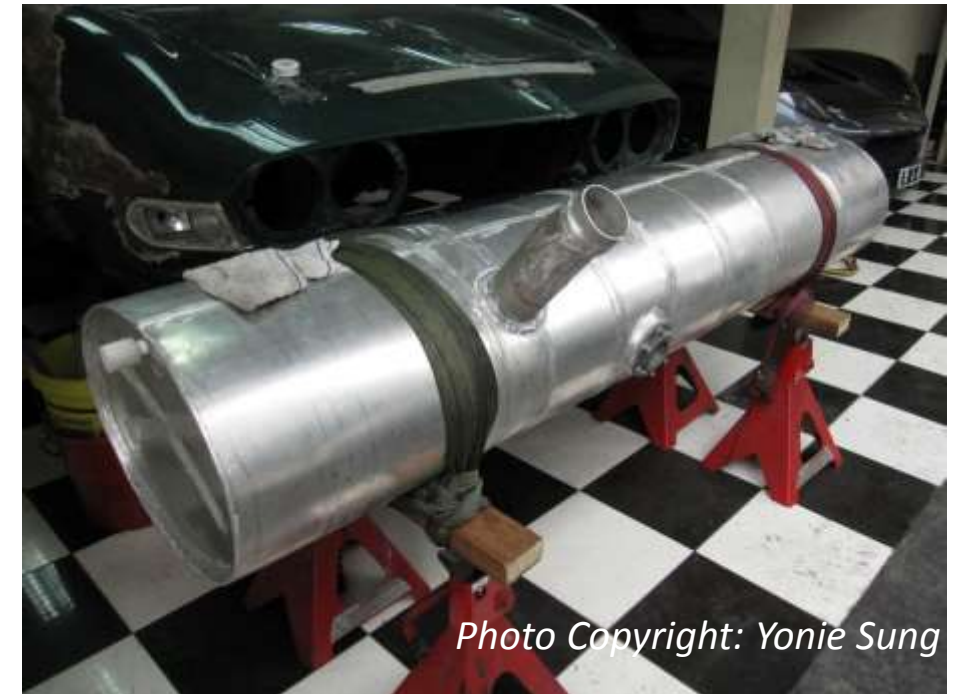
**Other mechanical repairs:**  
**Engine timing adjustment, New exhaust**  
**silencer, New fuel tank, Brake and tires**  
**etc...**

Other mechanical reparations included timing adjustment of the Gardner-made 6LXB engine, provision of new exhaust silencer, fuel tank, brake and tyres before the restored Guy was put on its first road test. Further tuning and adjustment followed the first short road test so that the vehicle was refined to a satisfactory condition for roadworthiness and ready for its public debut outside City Hall in Central on 15/1/2017 (Sunday).
