RAIB investigations: the risks that we see

Carolyn Griffiths
Chief Inspector
Rail Accident Investigation Branch

Passenger train derailment at East Langton 20 February 2010

Camden Road Oct 2013

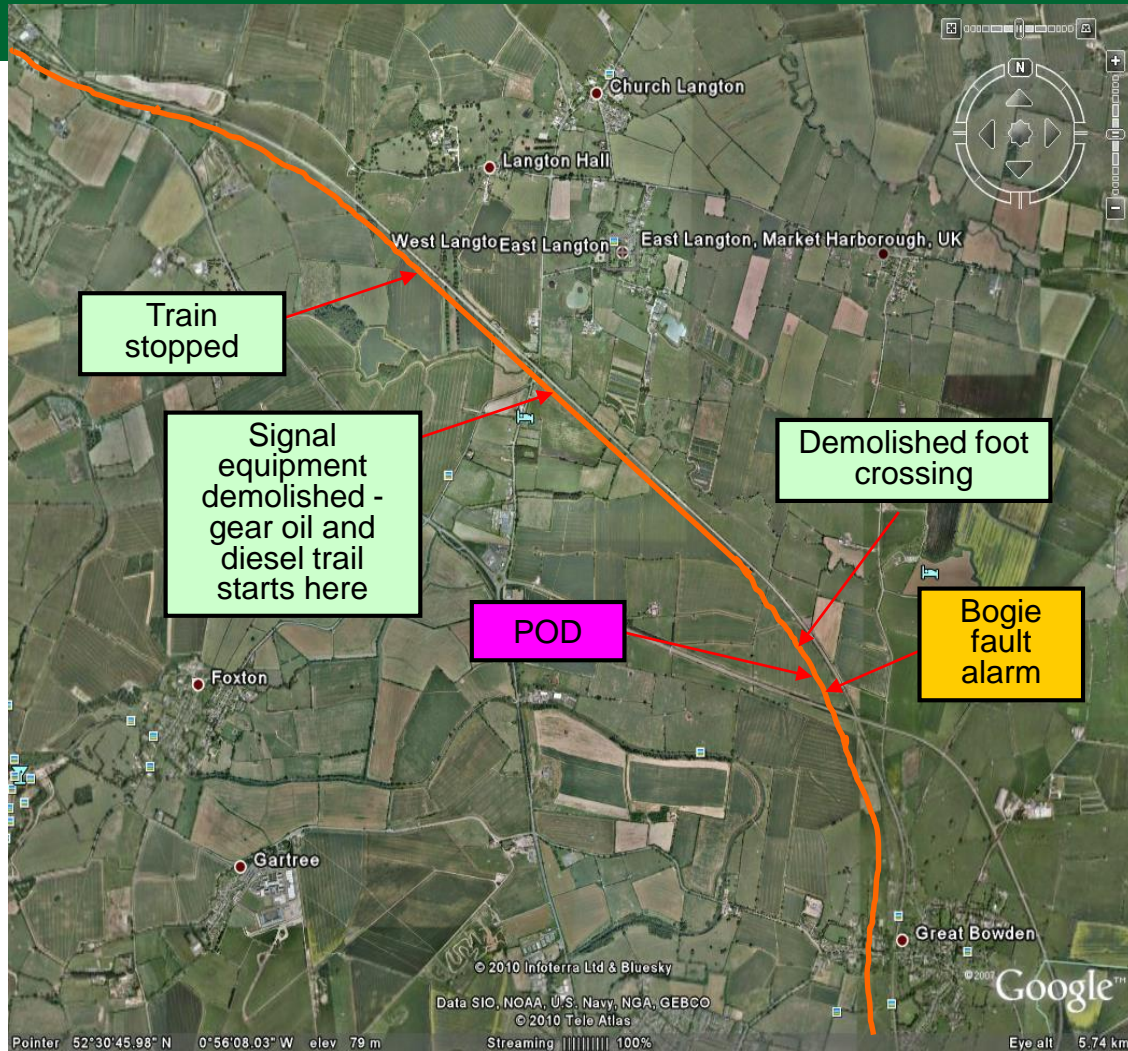
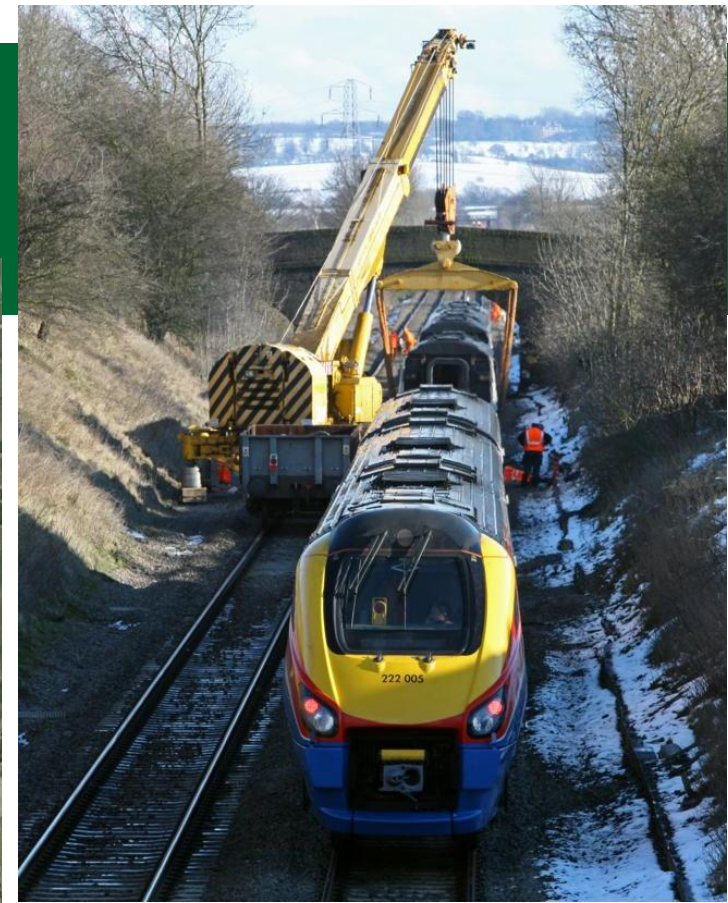
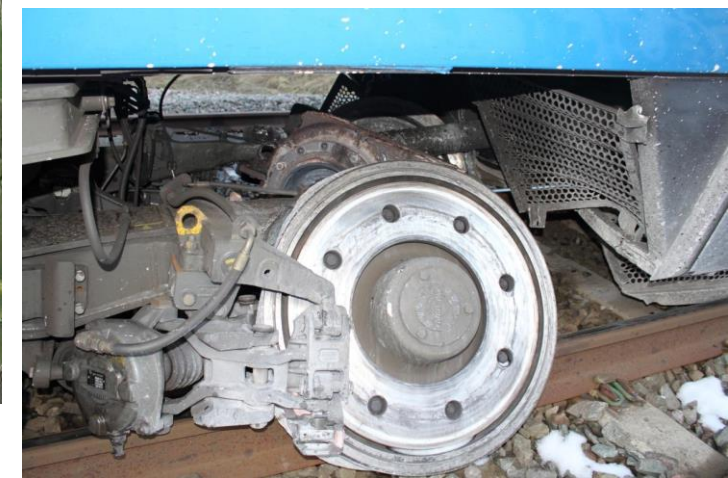
The derailment

Location of axle failure

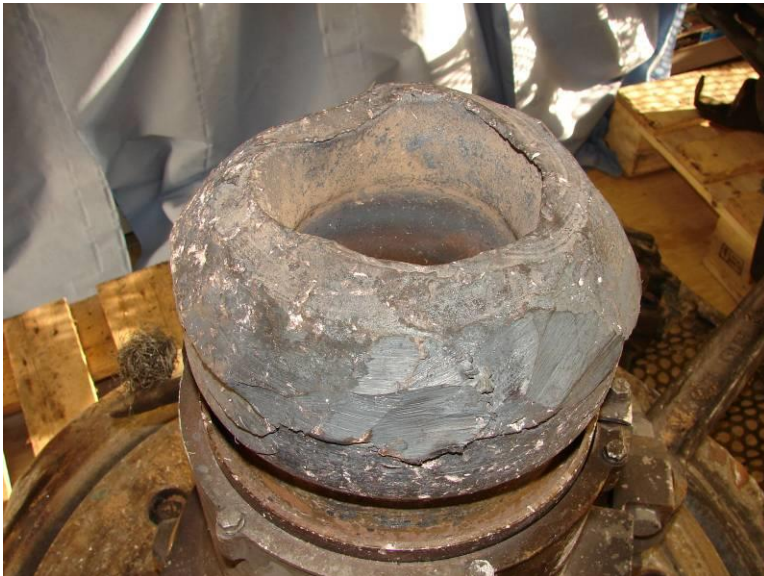
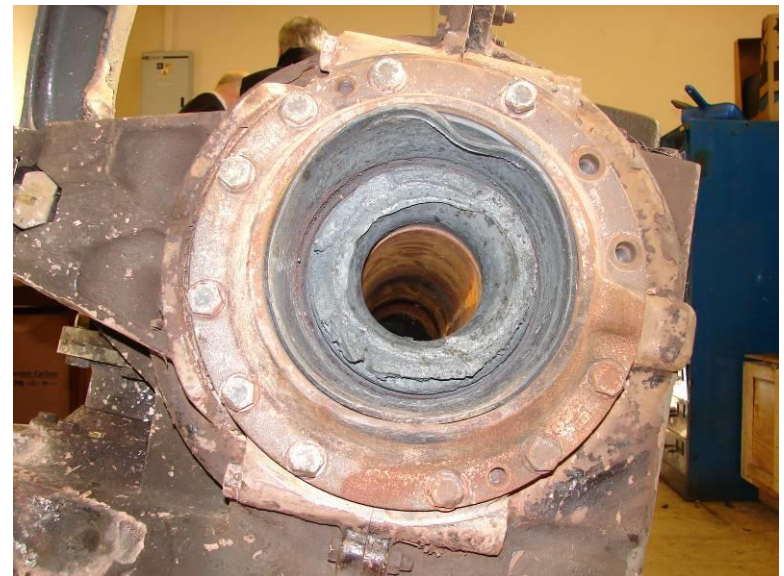
RHS half

- Axle fracture caused by rapid overheating
- Overheating caused by spinning of the axle within the inner ring of the GE bearing, which had become stiff.
- Bearing probably became stiff due to a clearance which had developed between the inner ring and axle.
- Likely causes of clearance:
 - Design fault resulted in a low initial interference fit.
 - Progressive loss of bearing interference fit in service due to bore growth and fretting wear.
 - Bearing seat on axle may also have been manufactured undersize.
- Also train operation issues – train took 2 miles to slow down after bogie warning light

1. Design review of Meridian/Voyager gearboxes to reduce the risk of recurrence. (Train and gearbox manufacturer)
2. Review and improvement of design, manufacture and overhaul procedures for final drives on other fleets, to ensure lessons from EL are built into industry practice (ROSCOs and other CEs, maintainers).
3. Review and optimisation of final drive oil sampling regimes for Meridian and similar fleets to improve failure detection capability (Train maintainer)
4. Practical rolling stock specific refresher training, including simulation, for drivers and train crew on handling emergencies. (Train operator)

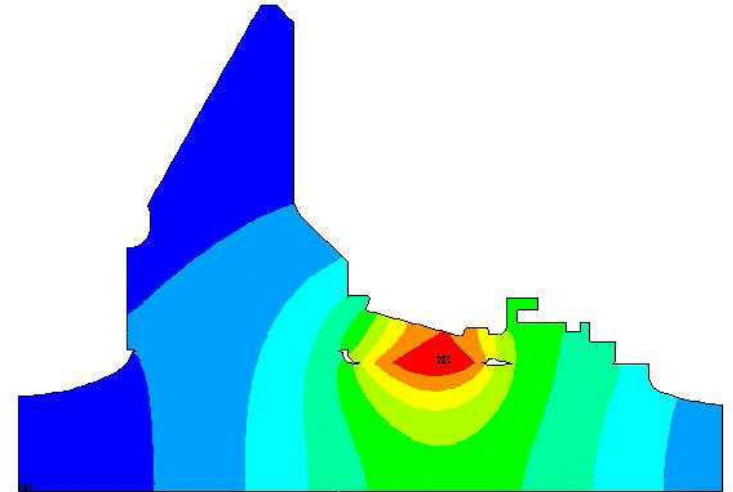
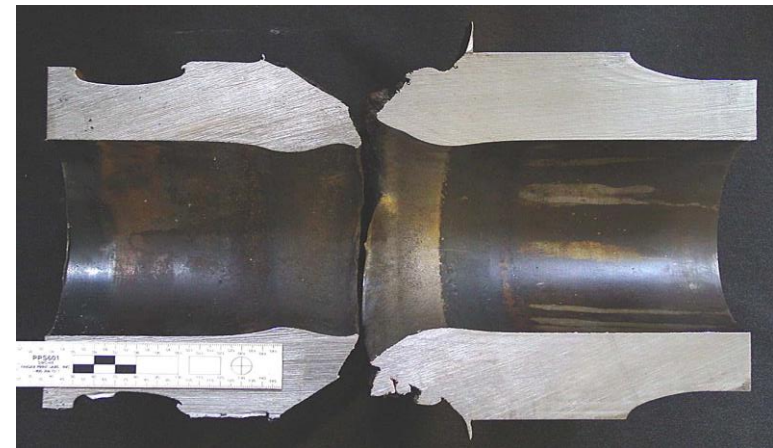
Technical lessons

Calculations show around 30 kW of heat input can be generated at the axle/inner ring interface.

30 kW can generate temperatures of around 1200C at the axle/inner ring interface in as little as 12 minutes.

Axle strength reduced to <10%.

Pre-condition is that GE bearing must stiffen up significantly (but not locked)

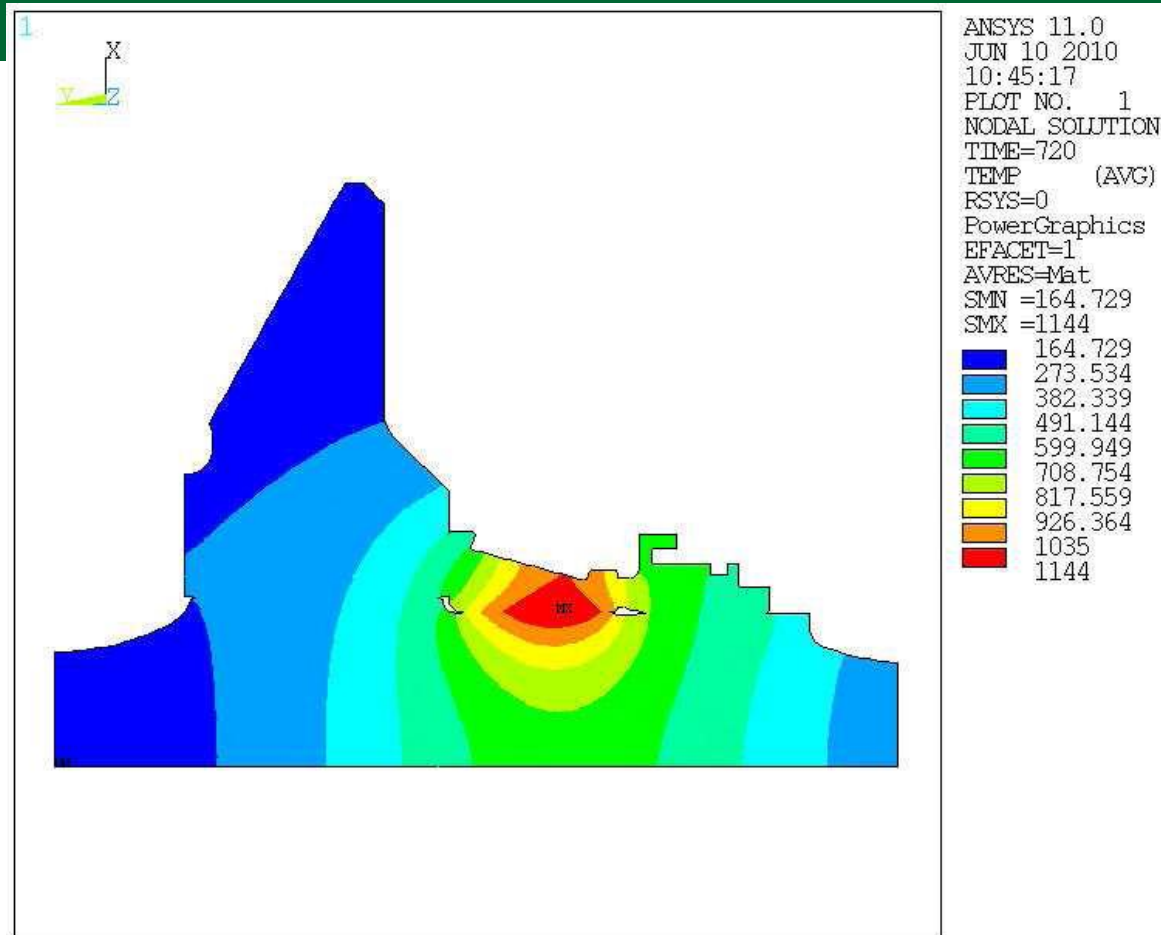
Technical lessons

- A heavy gear interference fit can cause significant shrinkage of a nearby bearing seat.
- Hollow axles are more vulnerable than solid axles
- Nearby interference fit needs to be allowed for at the design stage.

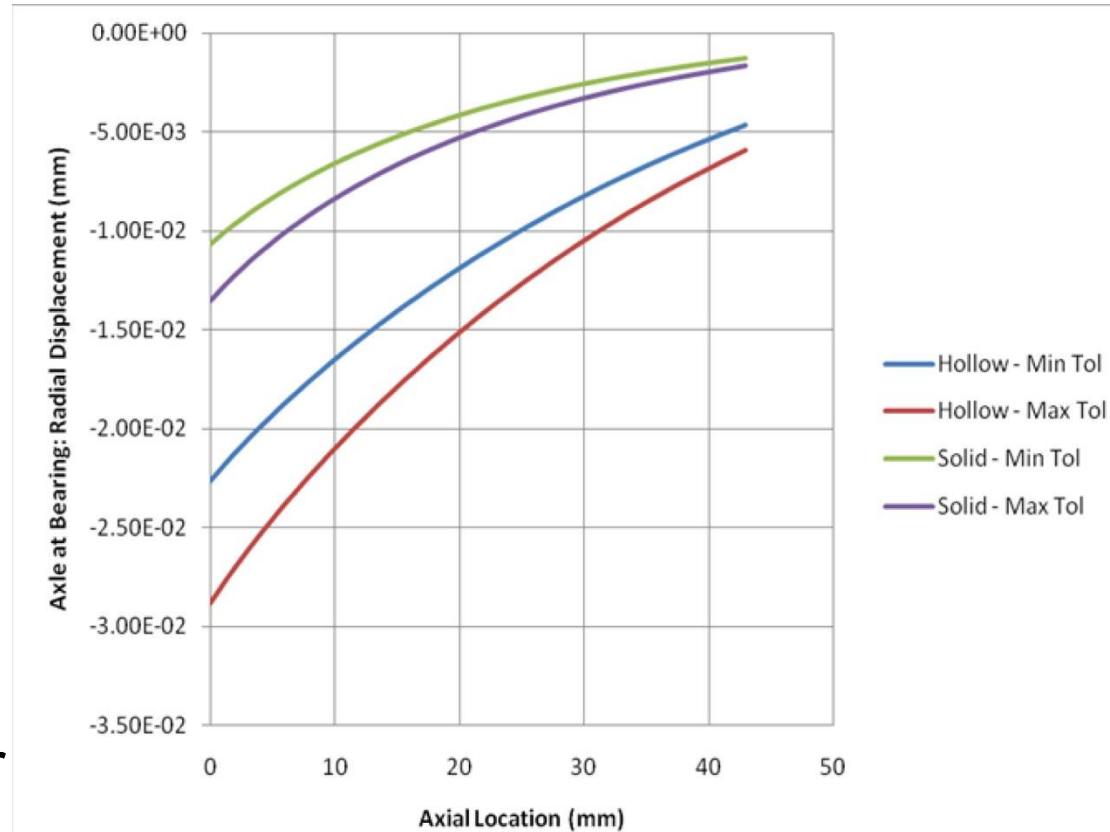
Technical lessons

- Inadequate bearing fits can lead to complete loss of interference and even clearance.
- 3 mechanisms:
 - inner ring growth
 - fretting
 - inner ring creep
- Once inner ring creep starts, fretting wear is accelerated, potentially leading to clearance.
- 3 wheelsets found with clearance (and severe fretting (see photo)).
- 2 wheelsets found with low interference

Reddish brown fretting residue found on axles with axle/inner ring clearances

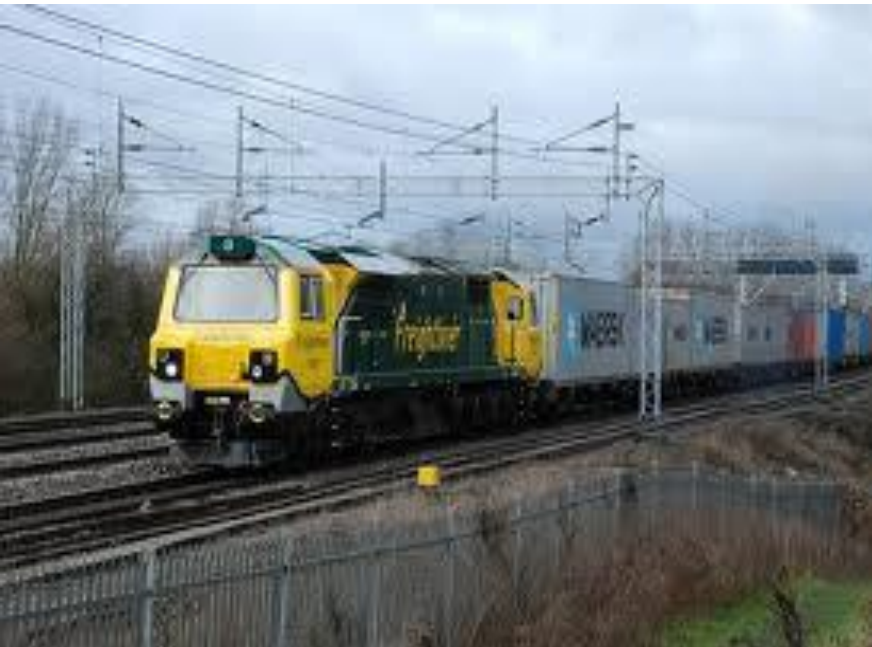
The accident

- Train from Birmingham to Felixstowe, containers for export
- 5th wagon derailed on 183 m radius curve
- Empty container toppled off wagon and brought down OLE
- Damage to track, OLE, viaduct wall, wagon and containers
- Section of North London Line (London orbital – busy throughout day) closed for 6 days

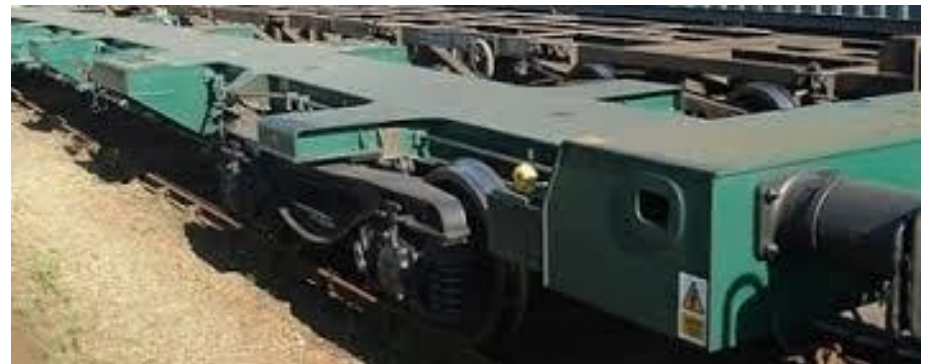
- FEA type loaded with 2 containers:
 - Laden 20' container with scrap electrical machines - weighing 28.8t at the front of wagon
 - Empty 40' container weighing 3.9t at the rear of wagon
- Rear bogie substantially damaged, remaining parts of wagon no relevant faults

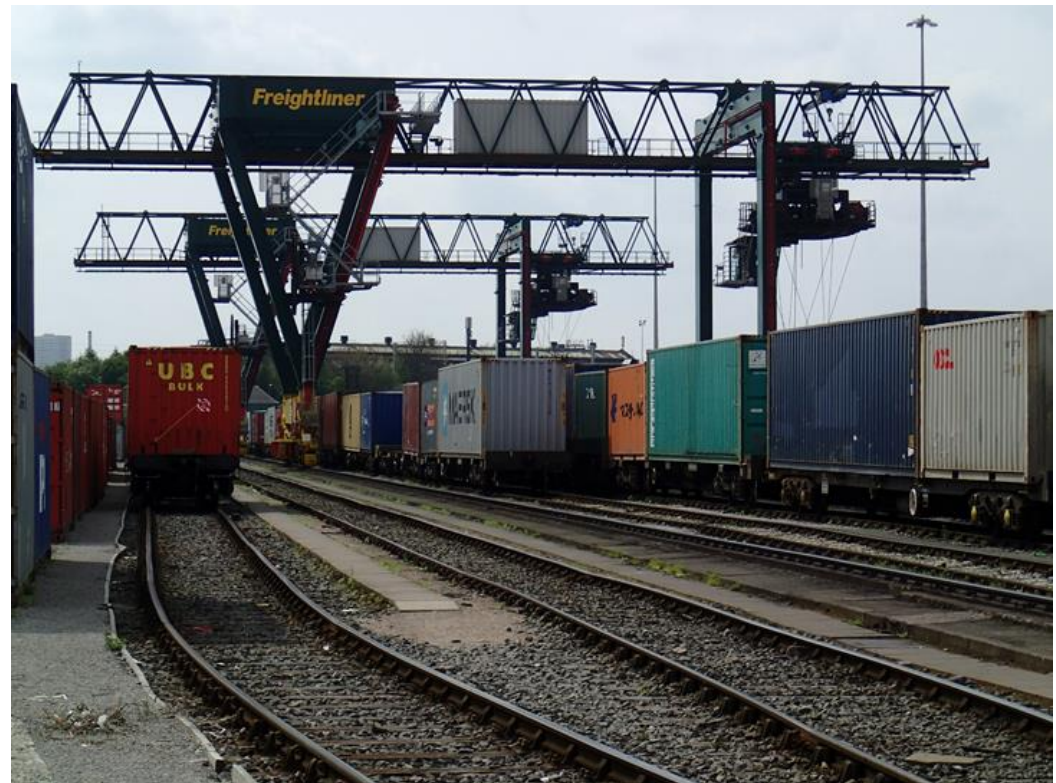
The track: multiple, opposing, twist faults

- Track twist measured over 3 metres - intervention regime based on this
- 3 metre-track twist at point of derailment required intervention within 7 days (not block the line)
- Wagon has axle centres at 2 metres (on each bogie) and bogie centres at 14 metres
- Filtering track survey data for 2 and 14 metre wavelengths shows a completely different picture (next slide)

Such measurements not routinely taken

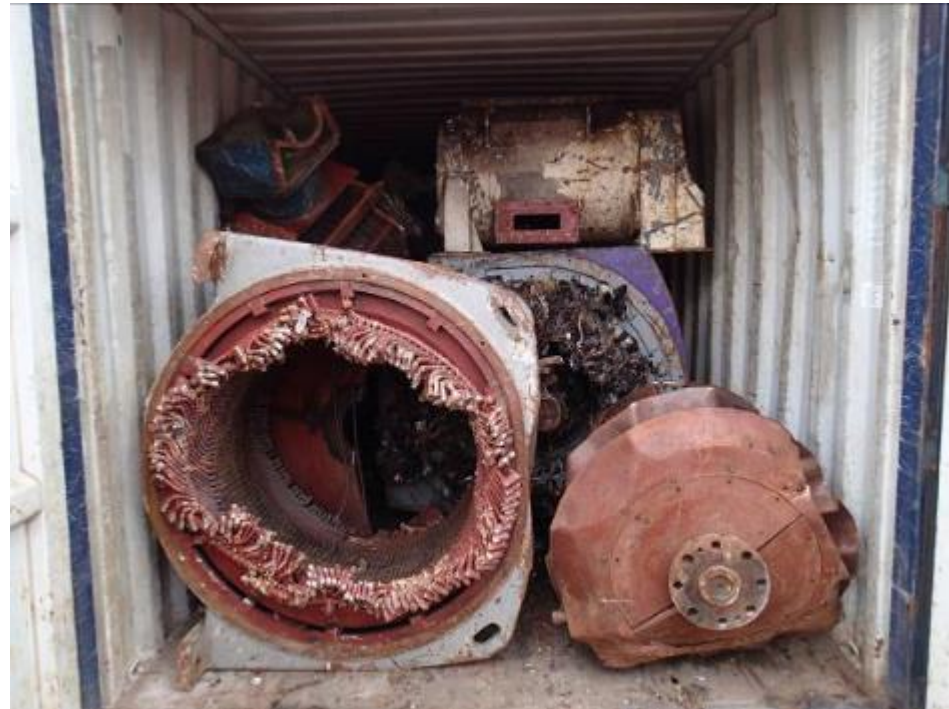
The wagon and its load

- 20 ft container ;leading end wagon
 - gross weight 28.83 t, offset centre of gravity
- Empty 40 ft container ; trailing end of the wagon
 - gross weight 3.88 tonnes
- Wagon centre of gravity offset both longitudinally and laterally

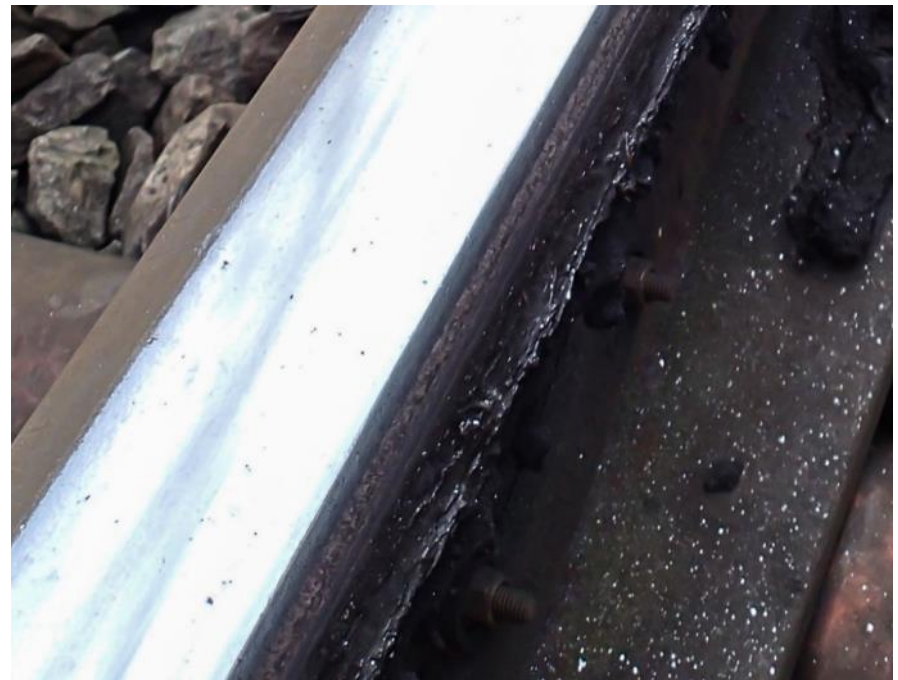
Other significant findings - track

- TRV last scheduled run cancelled
- No check rail to provide lateral restraint
- Flange lubricator not applying grease to gauge corner
- Asset knowledge - affected by high turnover of local management staff

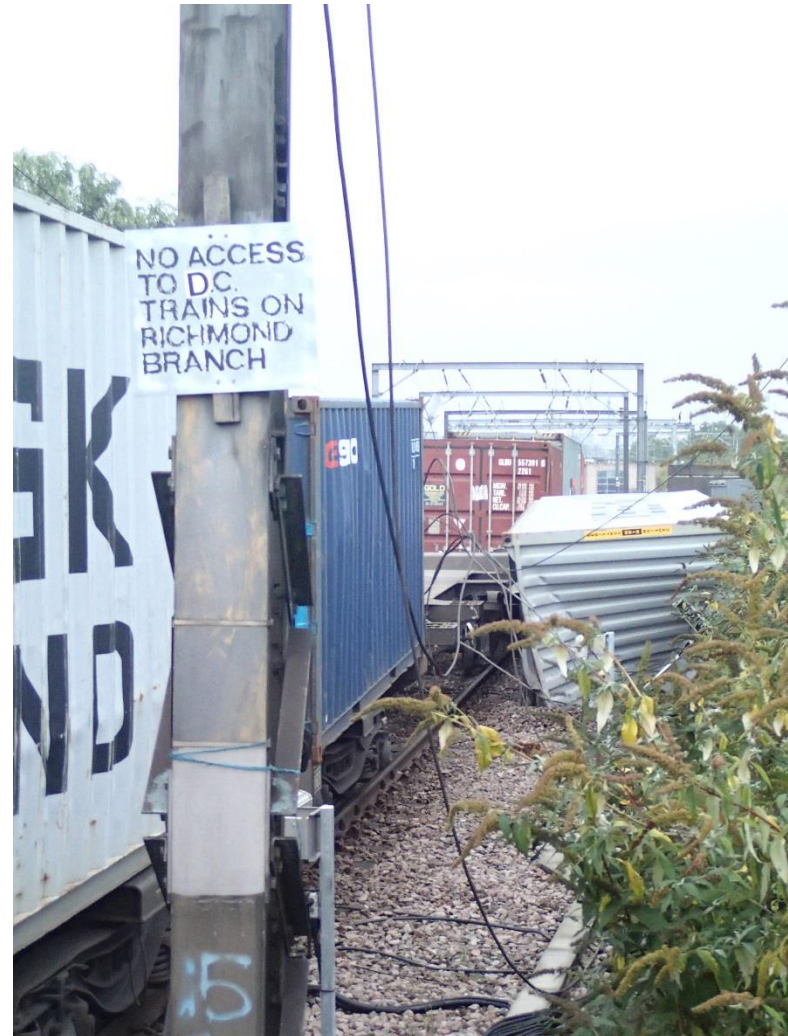
Conclusions

- Wagon derailed due to combined high level of longitudinal and lateral load imbalance
- At this location due to a compound track twist, wavelengths corresponding to both bogie wheelbase and bogie spacing

- Changes to track inspection and maintenance criteria
- Improvements to lubrication at the wheel/rail interface
- Reducing the permissible longitudinal weight ratio for wagons
- Identifying asymmetrical loading (at terminals or shortly after departure)
- Modifications to wagons : more tolerant of asymmetric loading

Recommendations made to industry to view these matters as a system issue and work together to define the right controls.
